Environmental and Ecological Planning Advisory Committee

The 7th Meeting of the Environmental and Ecological Planning Advisory Committee
June 20, 2019
Committee Rooms #1 and #2

That it BE NOTED that the Old Victoria - Grenier Lands Geotechnical Investigation - Slope Assessment prepared for Sifton Properties Limited by exp Services Inc., was received.

**Old Victoria – Grenier Lands &
1645 Hamilton Road
London, Ontario**

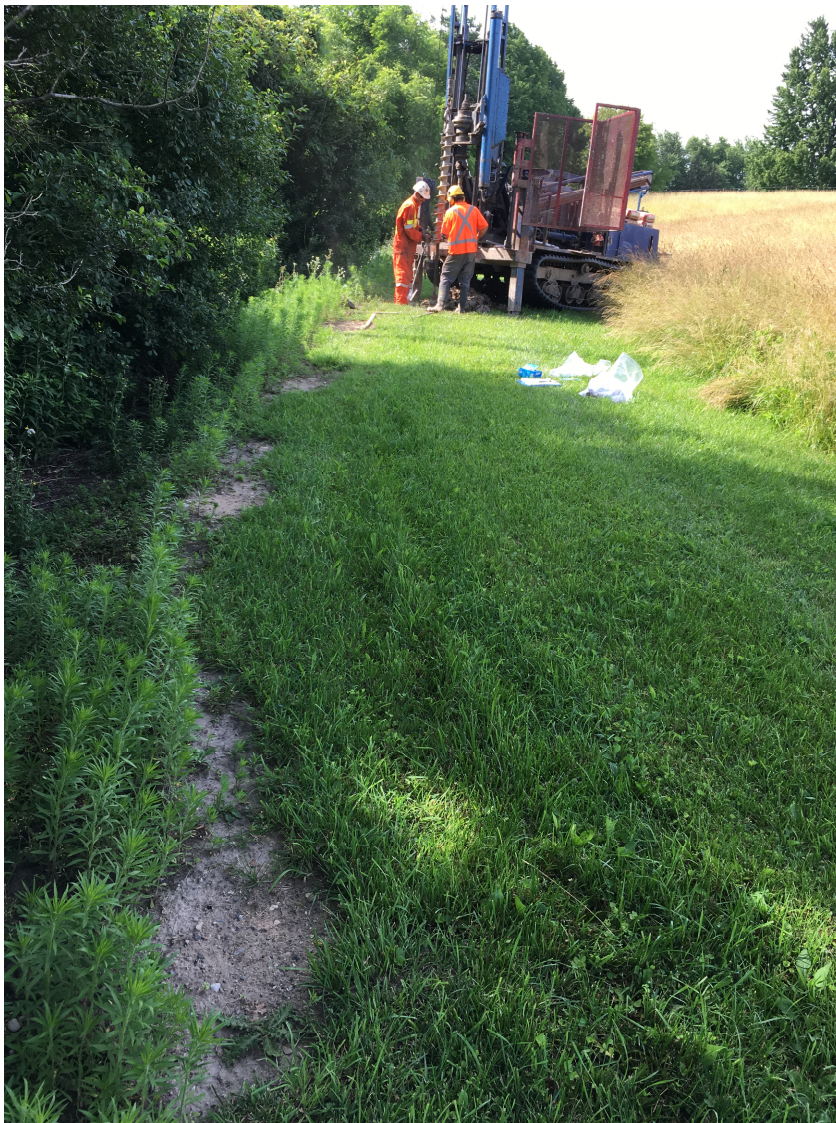
Photo 1 – Tableland and slope crest at Borehole BH1.

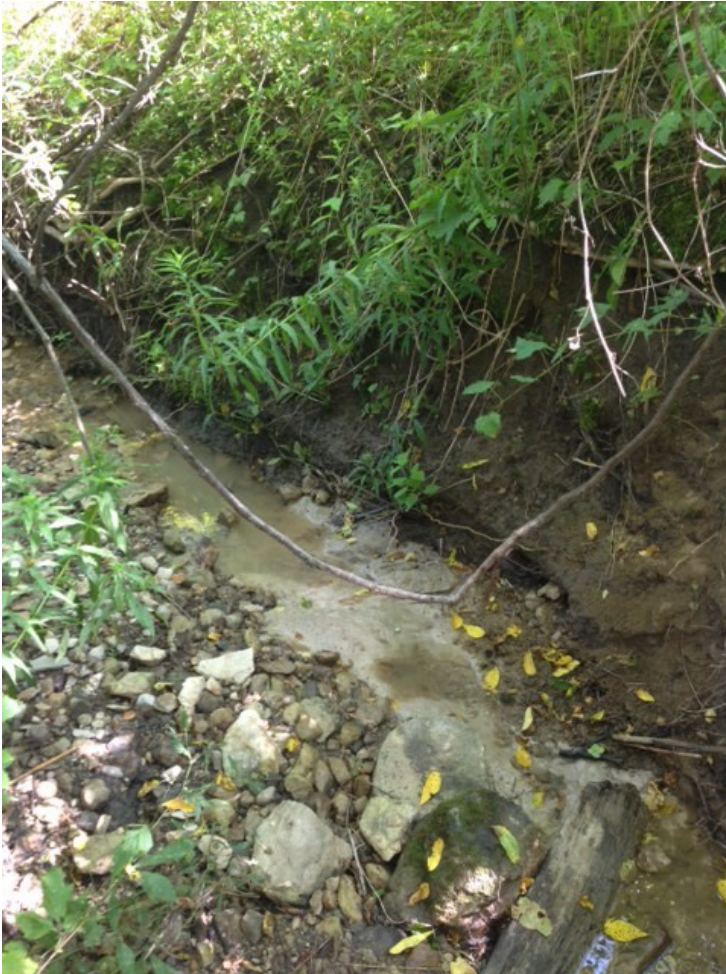
Photo 2 – Drainage Creek Base

The slopes along the watercourse are well vegetated, with a mixture of young and mature trees, and heavy brush. No overturning or bending of the existing trees was observed. This is a sign that significant movement of the soils in the slope has not occurred.

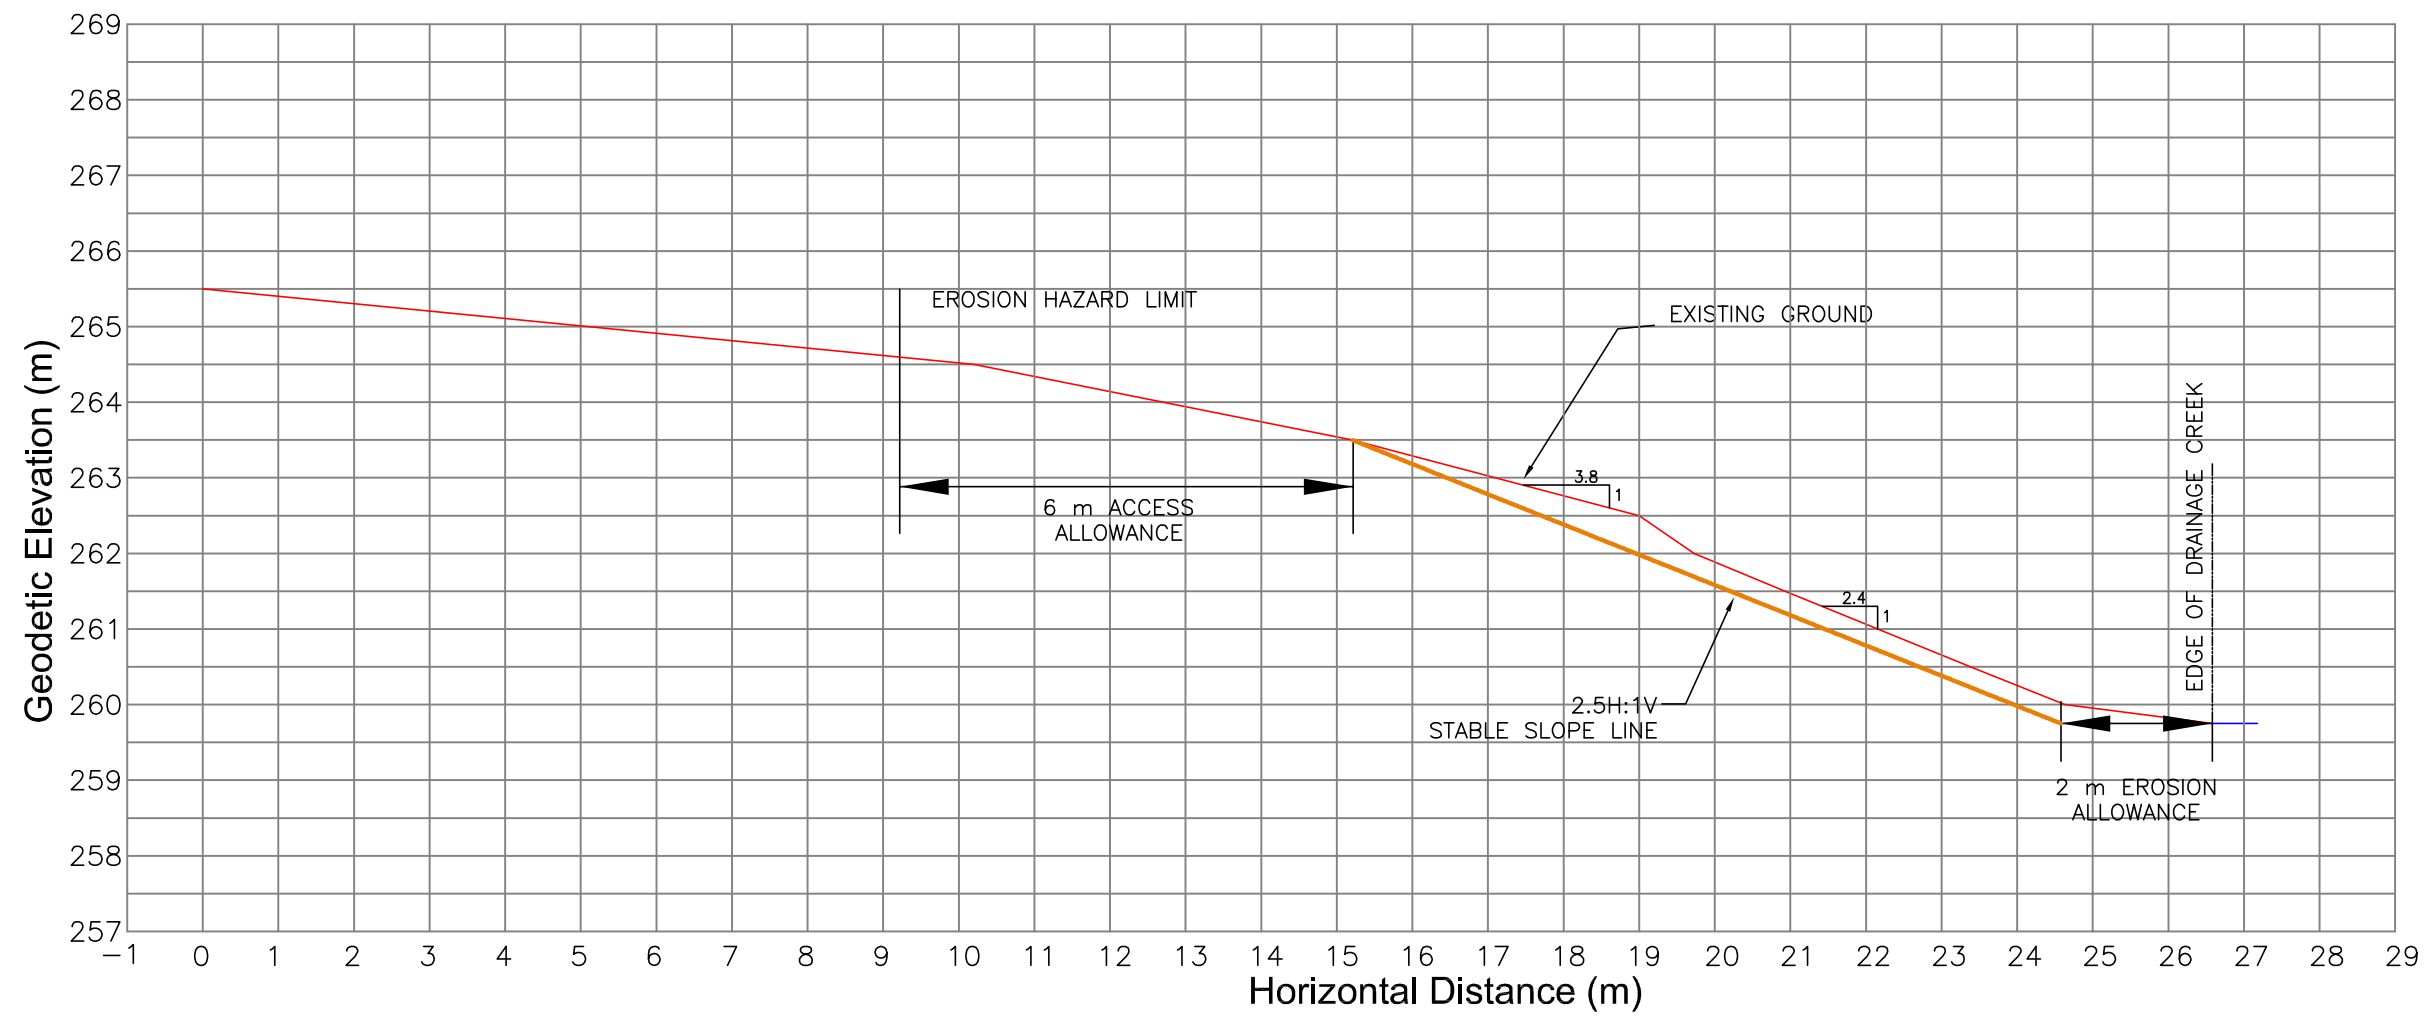
-NOTES-			
1. Drawing should be read in conjunction with exp report KCH00238640-GE.			
CLIENT	SIFTON PROPERTIES LIMITED		
PROJECT	GRENIER LANDS SLOPE ASSESSMENT		
TITLE	CROSS SECTION A - A

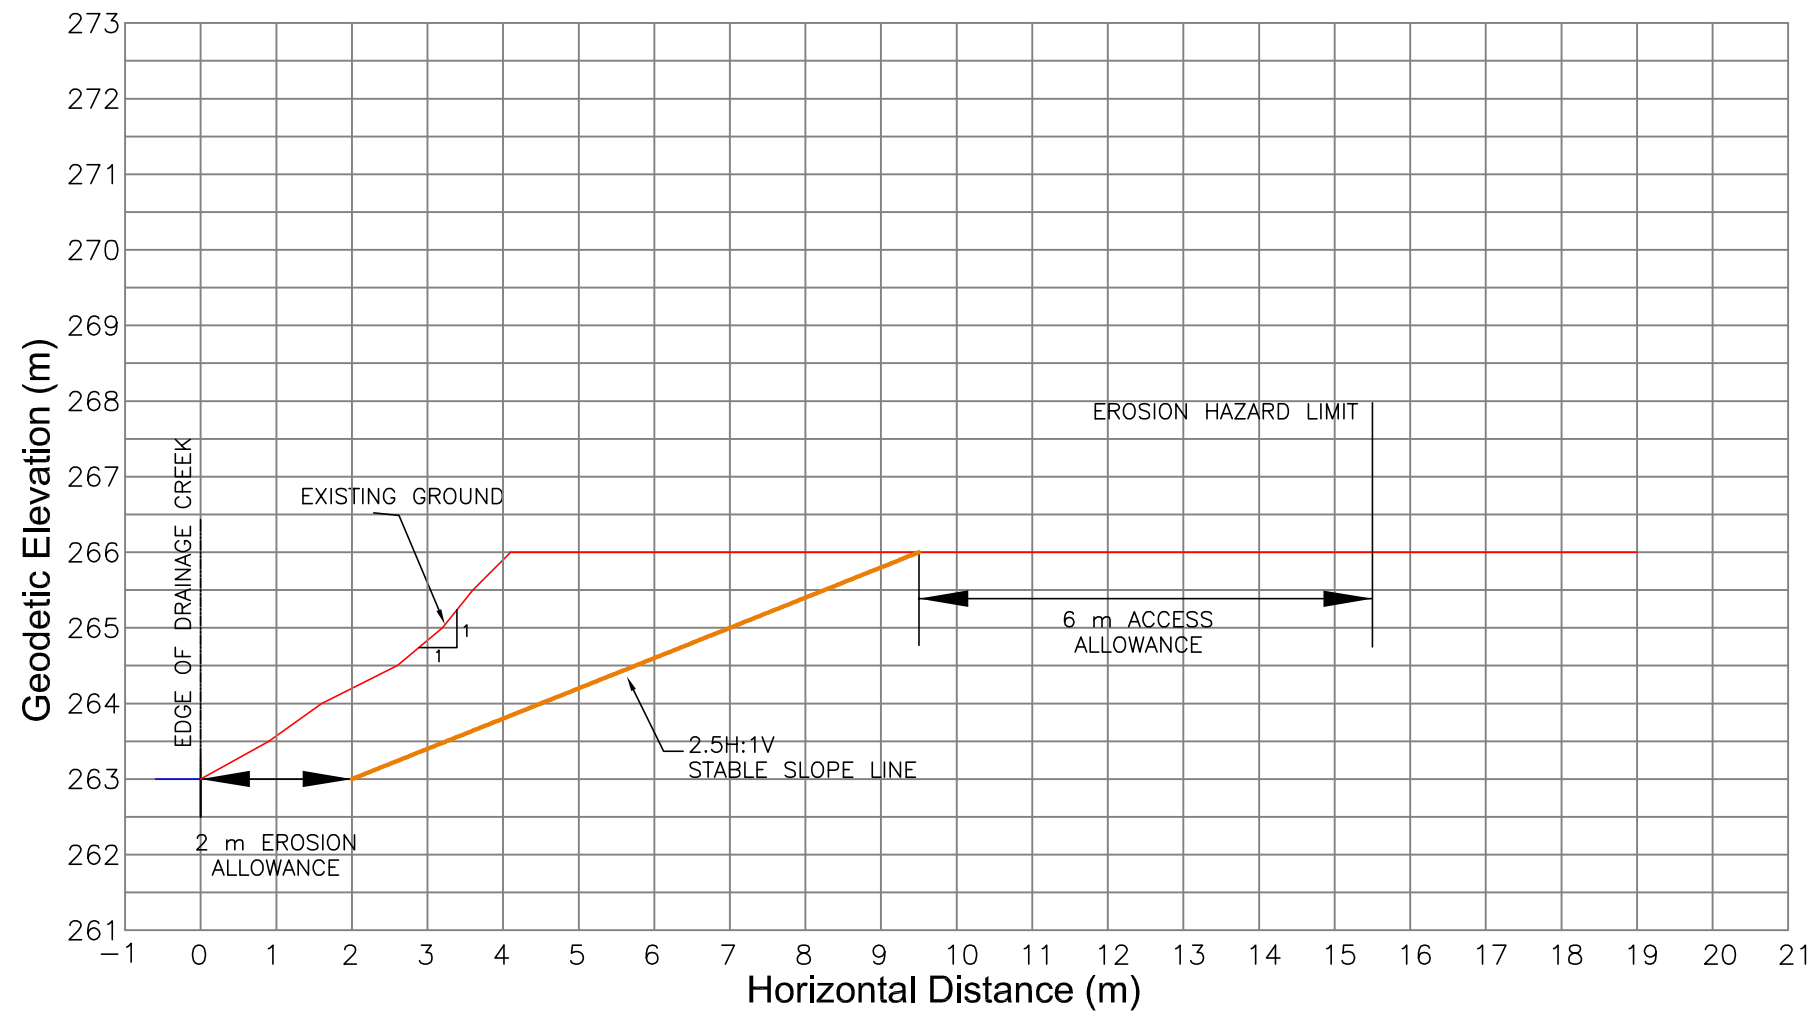
-NOTES-			
1. Drawing should be read in conjunction with exp report KCH00238640-GE.			
CLIENT	SIFTON PROPERTIES LIMITED		
PROJECT	GRENIER LANDS SLOPE ASSESSMENT		
TITLE	CROSS SECTION D - D

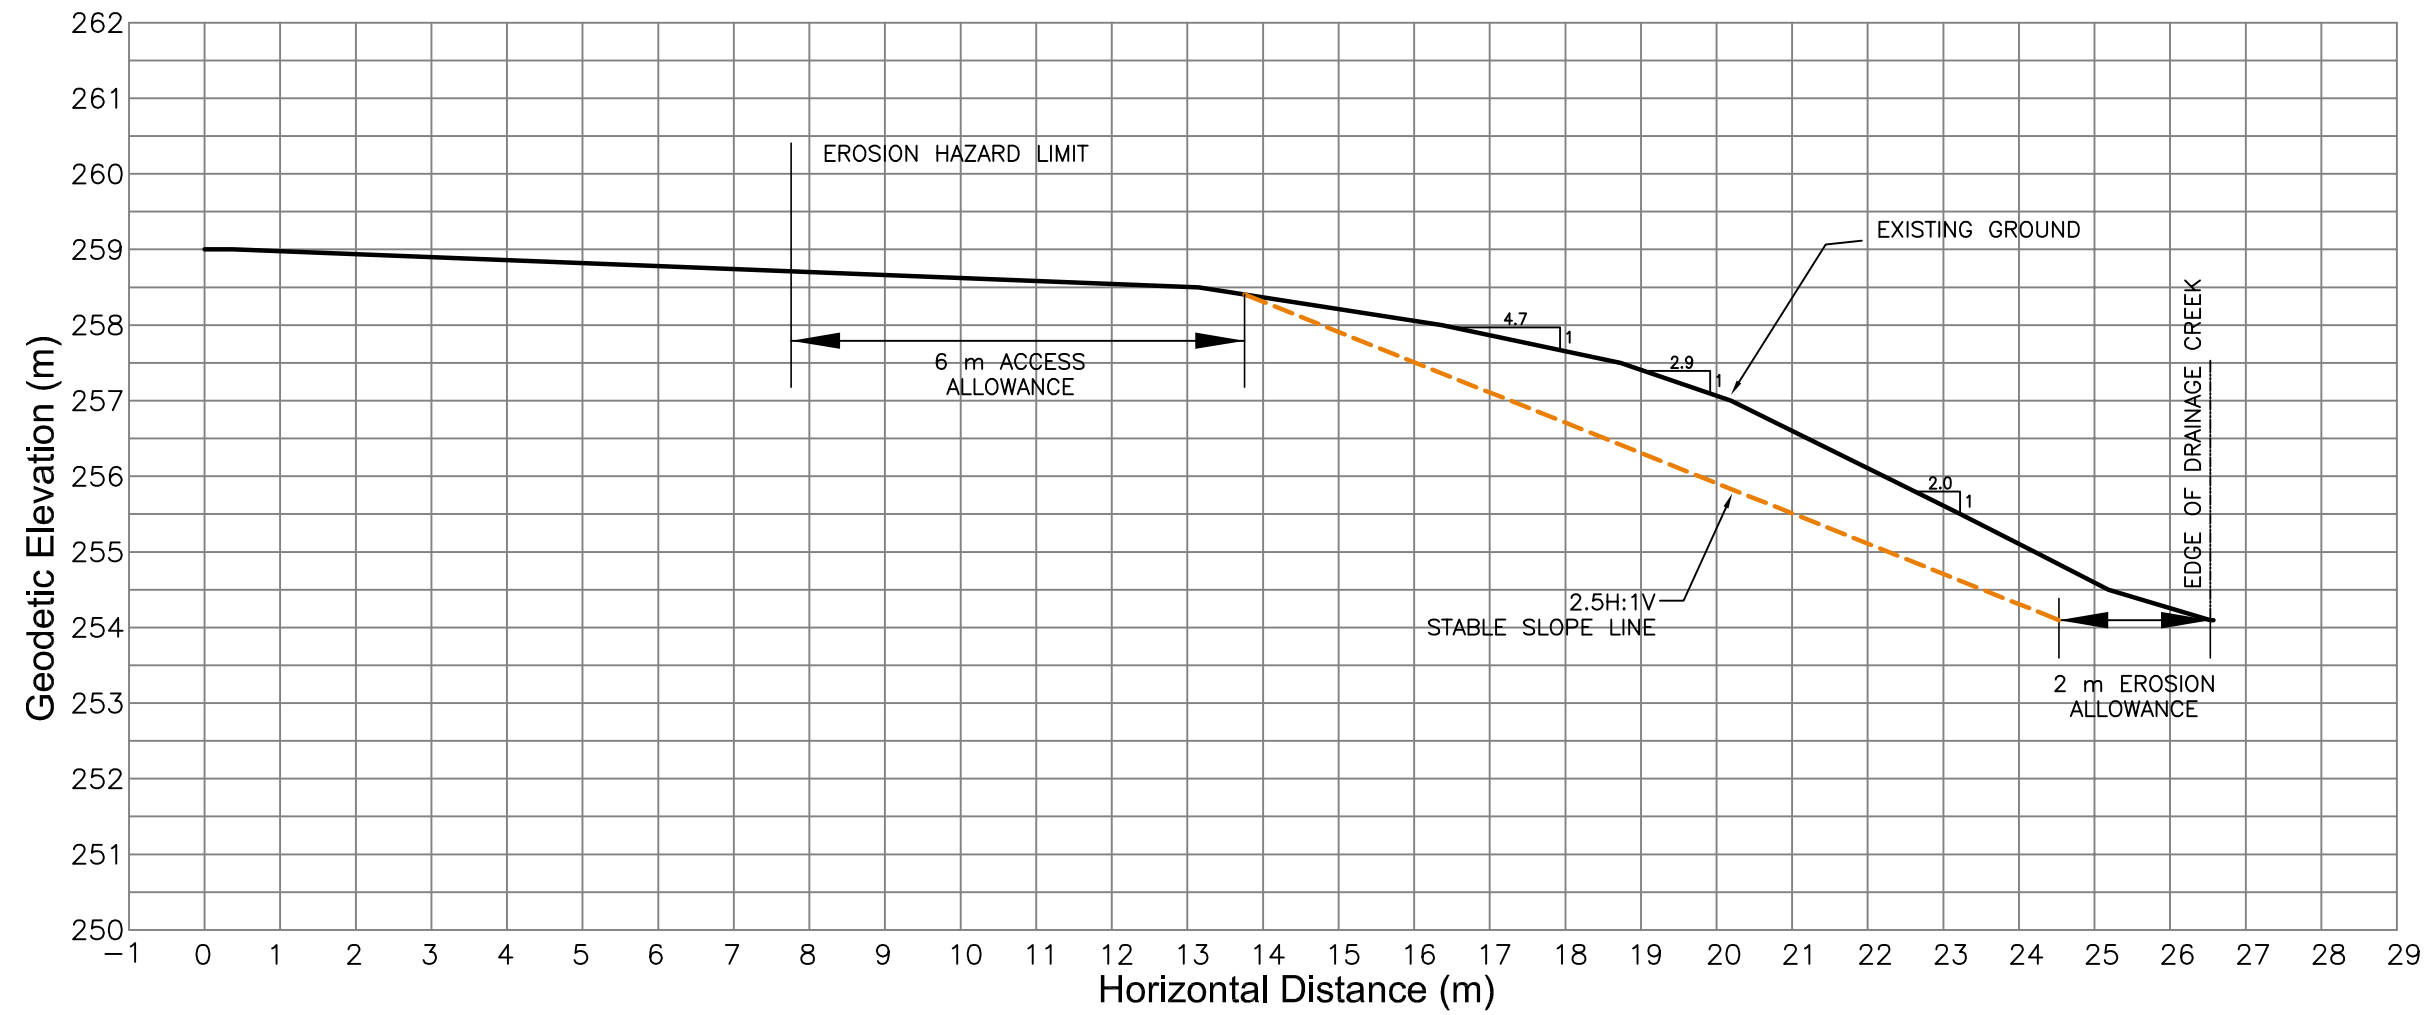
-NOTES-		CLIENT	SIFTON PROPERTIES LIMITED
1. Drawing should be read in conjunction with exp report KCH00238640-GE.		PROJECT	GRENIER LANDS SLOPE ASSESSMENT
		TITLE	CROSS SECTION F - F
