**HERITAGE IMPACT ASSESSMENT FOR
126, 128, 130, 132 DUNDAS STREET, AND
129 CARLING STREET,
CITY OF LONDON, ONTARIO**

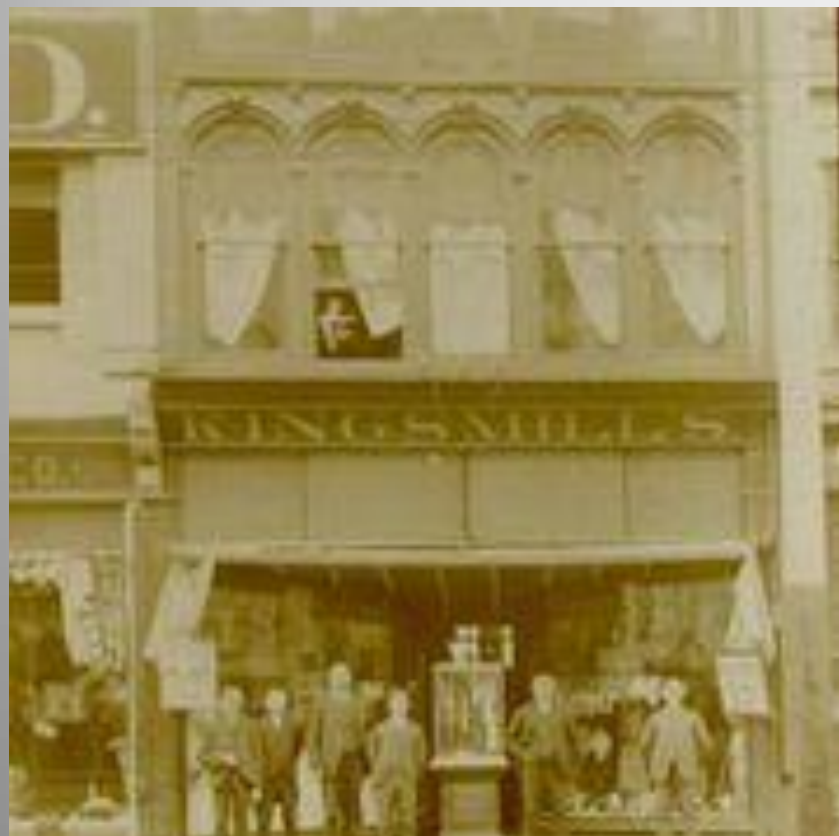
Photograph taken between 1865 & 1876. The earliest photographic record of the store

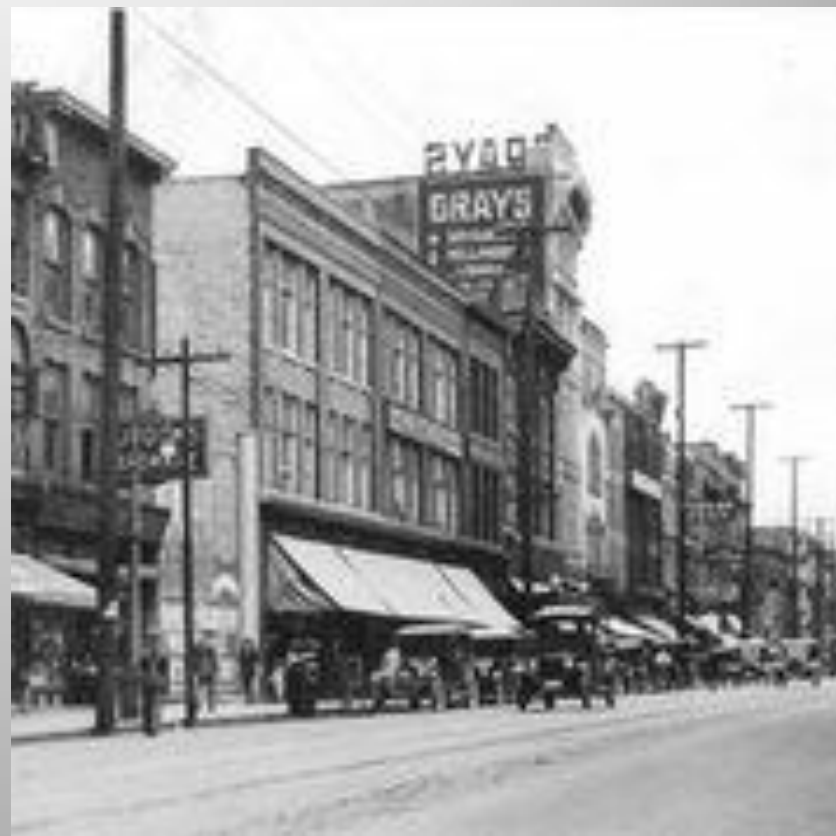
Photograph taken after the 1911 fire – note the empty lot to the west of Kingsmill's

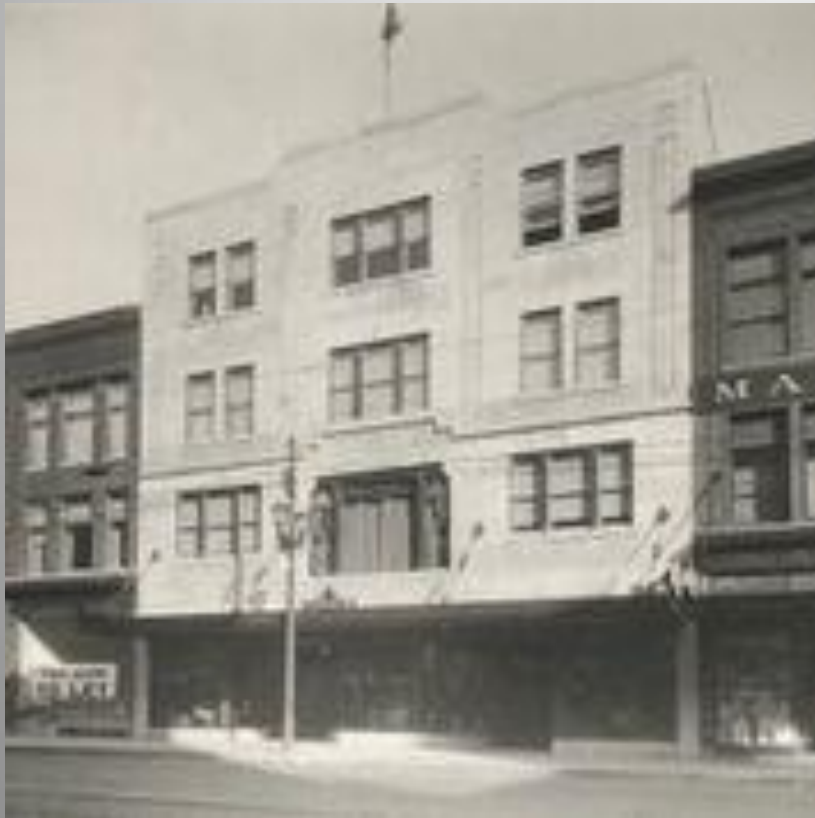
Photograph of Kingsmill's taken in 1932 after the new Art Deco façade was built

- 130, 132 Dundas Street consists of an art deco limestone façade. This façade is a representative example of art deco and includes a ziggurat (zigzag stepped horizontal pediment), a flat roof, three sections separated by vertical banding and a flat canopy held up by wrought iron tie rods. The Kingsmill's sign is inscribed onto the front of the second floor.
- 126, 128 Dundas Street consists of an Edwardian classicism design of red brick. This façade is representative of Edwardian classicism where the classical features of colonettes, voussours, and keystones are part of the style but are applied sparingly and with understatement. This post World War 1 period of architecture provided simple balanced designs, straight rooflines, uncomplicated ornament and maintenance-free detailing.

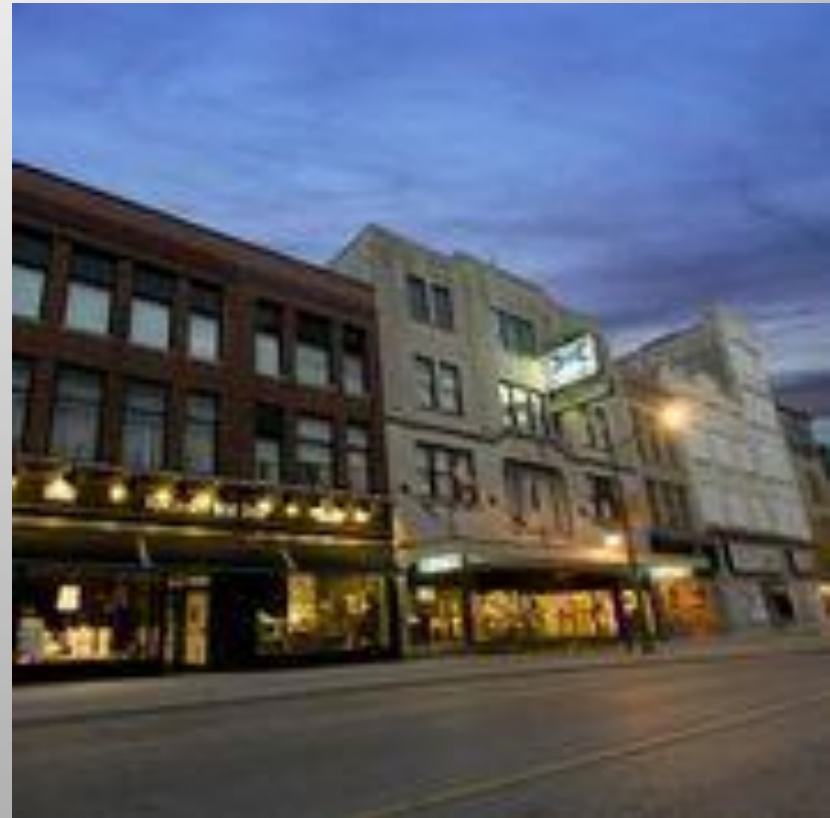
Kingsmill's store circa 2010

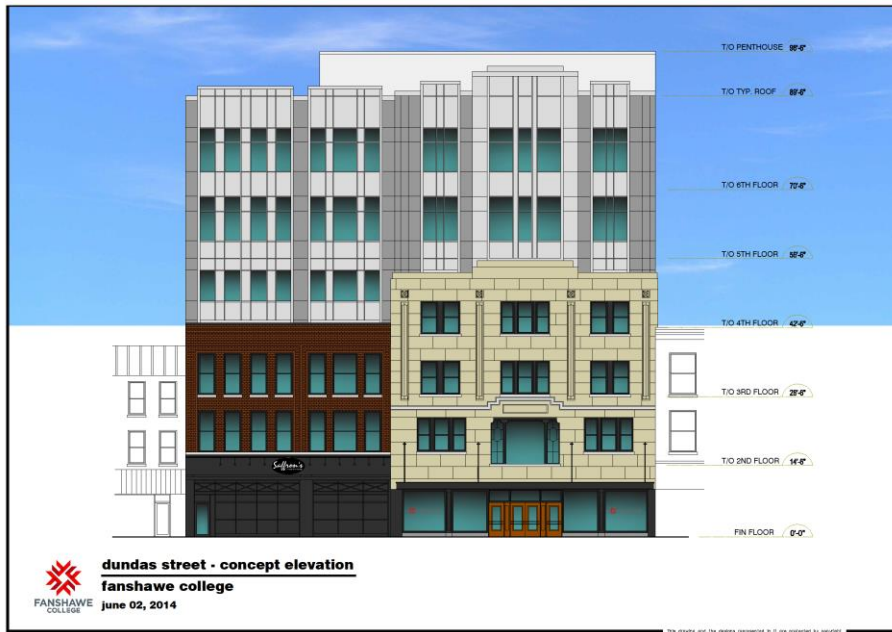
Proposed Dundas Street Elevation

South Elevation – The existing façade will be preserved. Temporary shoring and bracing will be provided to stabilize the façade during construction until final incorporation into the new structural framing. The existing limestone and clay brick façade will be professionally restored using some of the materials salvaged from the demolition of Carling Street.

South Elevation – cont'd. Existing wooden windows will be replaced with new energy efficient units that have a similar appearance to the existing windows. The south storefront will be brought forward to the sidewalk to showcase the existing set of doors. The ground floor storefront will incorporate windows set in frames with a bronze finish highlighted by granite accents. From the 4th and 5th floors up the façade will be traditional aluminum curtain wall with a 4.6 metre (15 foot) setback;

The existing façade on Dundas Street will be preserved. Temporary shoring and bracing will be provided to stabilize the façade during construction until final incorporation into the new structural framing. The existing limestone and clay brick façade will be professionally restored using some of the materials salvaged from the demolition of the north Carling Street side.

The additional three floors will be traditional aluminum curtain wall with a 4.6 metre setback. They will carry forward the rhythm of the existing windows in both façades.

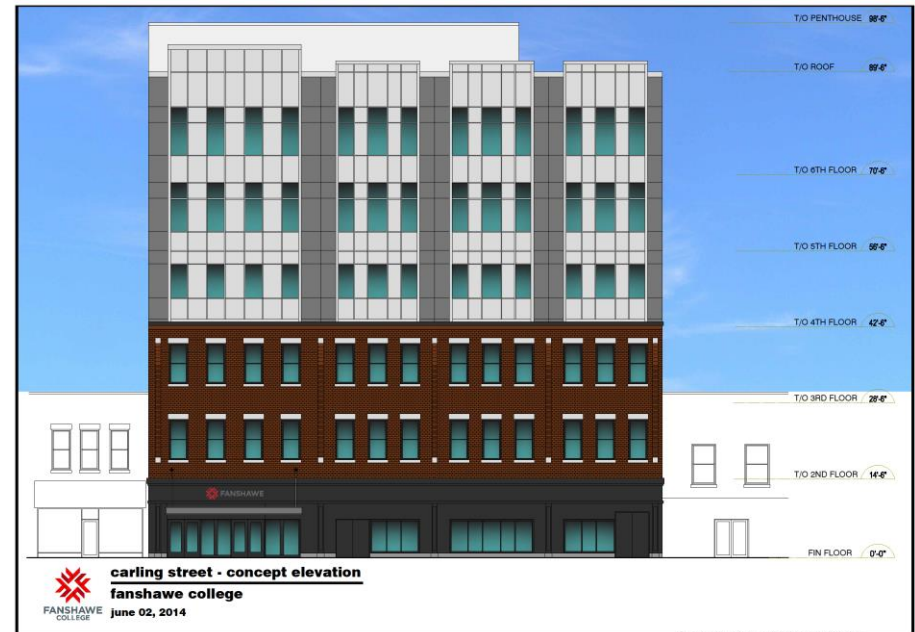
Proposed Carling Street Elevation

North Elevation - Demolition of the Carling façade down to foundation level and complete re-construction utilizing appropriate historic reproductions of materials on the first 3 floors, including granite, clay and stone window sills and lintels to recreate an appearance similar to the existing. From the 4th floor up the façade will be traditional aluminum curtain wall with a 4.6 metre (15 foot) setback;

The existing limestone and clay brick façade will be professionally restored using materials salvaged from the demolition of the north Carling Street side. The Carling Street façade will be rebuilt using modern red brick to replicate what was removed.
