The Downtown Heritage Conservation District Plan

Downtown London

Heritage Conservation District Plan

161401203

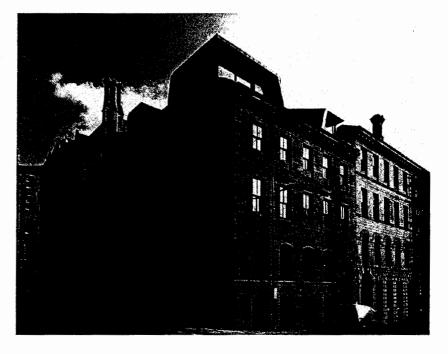
After

The Hanover House project is an example of an addition to an existing Victorian Warehouse that illustrates the creative license that is possible when rehabilitating an existing building. Note that the setback means that from street level the addition does not interfere with the existing streetscape.
