HAP 17-039-L
K. Gonyou

TO:	CHAIR AND MEMBERS LONDON ADVISORY COMMITTEE ON HERITAGE MEETING ON WEDNESDAY JULY 12, 2017
FROM:	JOHN M. FLEMING MANAGING DIRECTOR, PLANNING AND CITY PLANNER
SUBJECT:	HERITAGE ALTERATION PERMIT APPLICATION AT 169 BRUCE STREET, WORTLEY VILLAGE-OLD SOUTH HCD BY: EMERALD TRADING CORP.

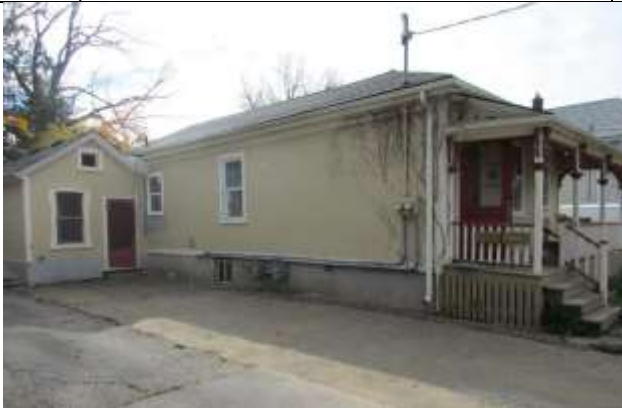
Image 3: Alterations windows at 169 Bruce Street (2016-11-10).

- Remove the existing concrete block chimney and reconstruct a new chimney in its place with concrete block;
- Retroactive approval for the construction of a new wooden porch at the side door, built on a wooden platform with wooden railings and posts; and,
- Retroactive approval for installation of a new 2'x3' window on the southeast corner of 169 A Bruce Street to allow more light into the studio unit. The stucco was cut to accommodate the window with a 3" x 3" lintel.

Section 8.3.1.1	
Recommended Practices and Design Guidelines	Analysis
f. Where replacement of features (e.g. doors, windows, trim) is unavoidable, the replacement components should be of the same style, size, proportion, and material wherever possible;	Style: The replacement windows are double hung sash windows, which is the same as the historic wood windows on the front (north) façade and other existing windows on the building.
	Size: One window was added and one window was reduced in size.
	Proportion: The reduction of the window impacts the relationship between the two windows on the east façade, as well as the new window further to the rear. As the building is rendered with parging, the cladding has been well finished to disguise any evidence of the alterations. Trim detail has been replicated to maintain some continuity with other window openings of the building.
	Material: The previous windows do not appear to be wood windows; the replacement window are vinyl, which is consistent with other replacement windows on the building. The windows on the main (north) façade are the original wood windows.

The reduction of the size of one window and the addition of one new window constitutes an adverse impact to this cultural heritage resource. These impacts have been mitigated by the use of consistent style of window with the other windows of the building, as well as the replication of the trim details. Because the building is parged, evidence of past alterations have been mitigated.

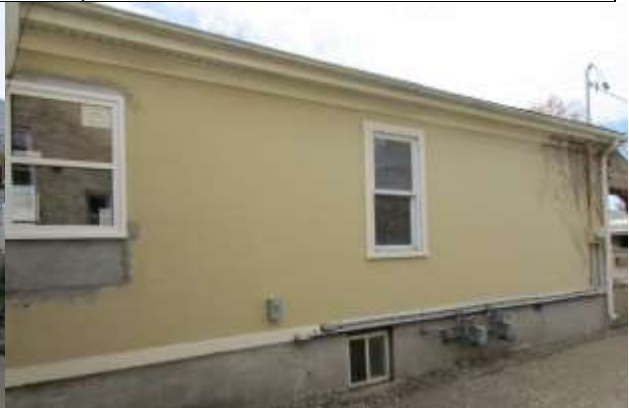
Image 4: Detail of altered window on the east façade (2016-11-10).

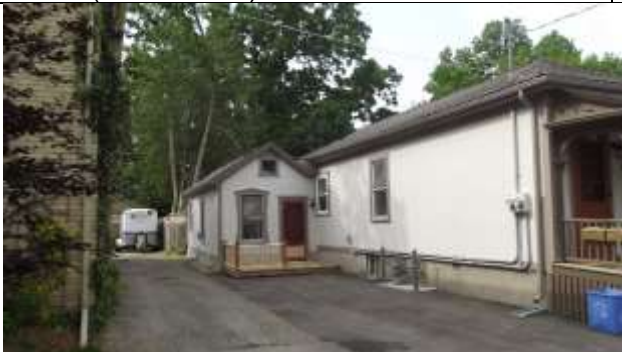
Image 5: Recent image of the east façade of the building at 169 Bruce Street (2017-06-13).

A small porch area at the entrance to 169 A Bruce Street was added (see Appendix B.

Image 5). Because of the height of the porch, no Building Permit was required. However, a Heritage Alteration Permit is still required.

Provided that the new porch is painted, it is compliant with the guidelines of the *Wortley Village-Old South HCD Plan* because it demonstrates compatibility with the existing verandah of the building at 169 Bruce Street. The railing of the new porch is consistent with that of the existing; a traditional wooden top and bottom rail, with square spindles set between, and square newel posts.

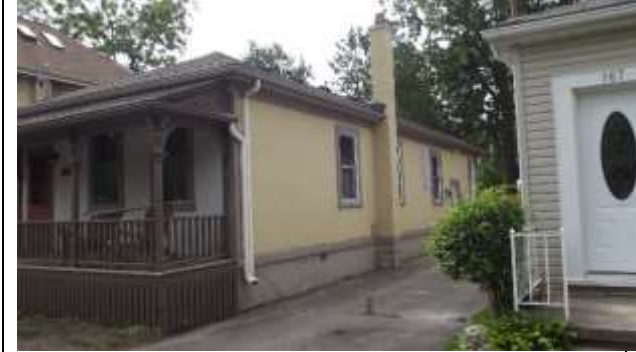
Image 7: West façade of the building at 169 Bruce Street showing the chimney (2017-06-13).

The existing chimney at 169 Bruce Street is not believed to be original to the construction of the building, but it contributes to the rhythm and pattern of chimneys that support the heritage character of the Wortley Village-Old South HCD. The existing chimney is in need of reconstruction. Section 9.3.3 of the *Wortley Village-Old South HCD Plan* recommends that the existing chimney be documented to allow for replication of design details. The existing concrete block could be used in the reconstruction of the chimney, but brick should be considered as it is a more historically appropriate material.

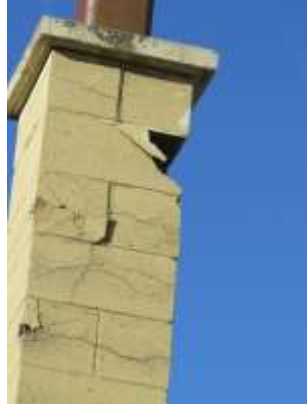
Image 8: Detail of the chimney (2016-11-15).
