Demolition Request – 123 Queens Avenue

London Advisory Committee on Heritage
Wednesday May 8, 2019

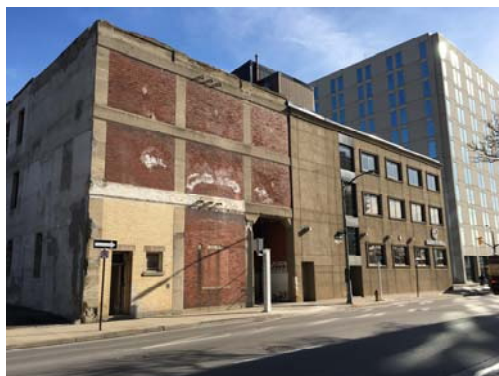
123 Queens Avenue

- Built between 1916-1922
- Three storey industrial structure
- Constructed of reinforced concrete
- Ornamental concrete diamonds
- Concrete parapet
- Recessed entrance with concrete lintel
- Connected to 450 Talbot

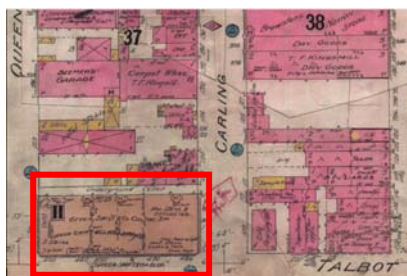
*Fire Insurance Plan 1912 Rev. 1915
(Courtesy of Western Archives)*

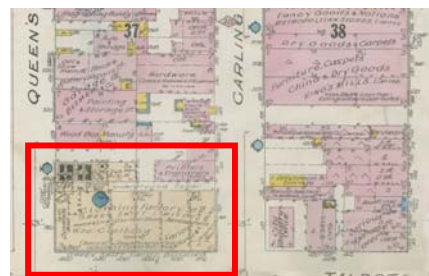
*Fire Insurance Plan 1912 Rev. 1922
(Courtesy of Western Archives)*

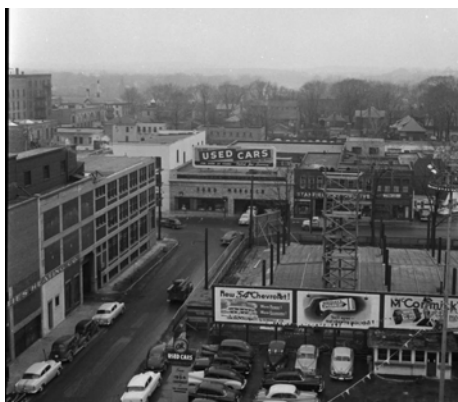
Photo of the front façade at 123 Queens Avenue looking west from Richmond (London Free Press, 1954).
