## Report to Planning and Environment Committee

**Subject:** Demolition Request for Heritage Designated Property at 123  
Queens Avenue by JAM Properties Inc.

**Public Participation Meeting on: Monday May 13, 2019**

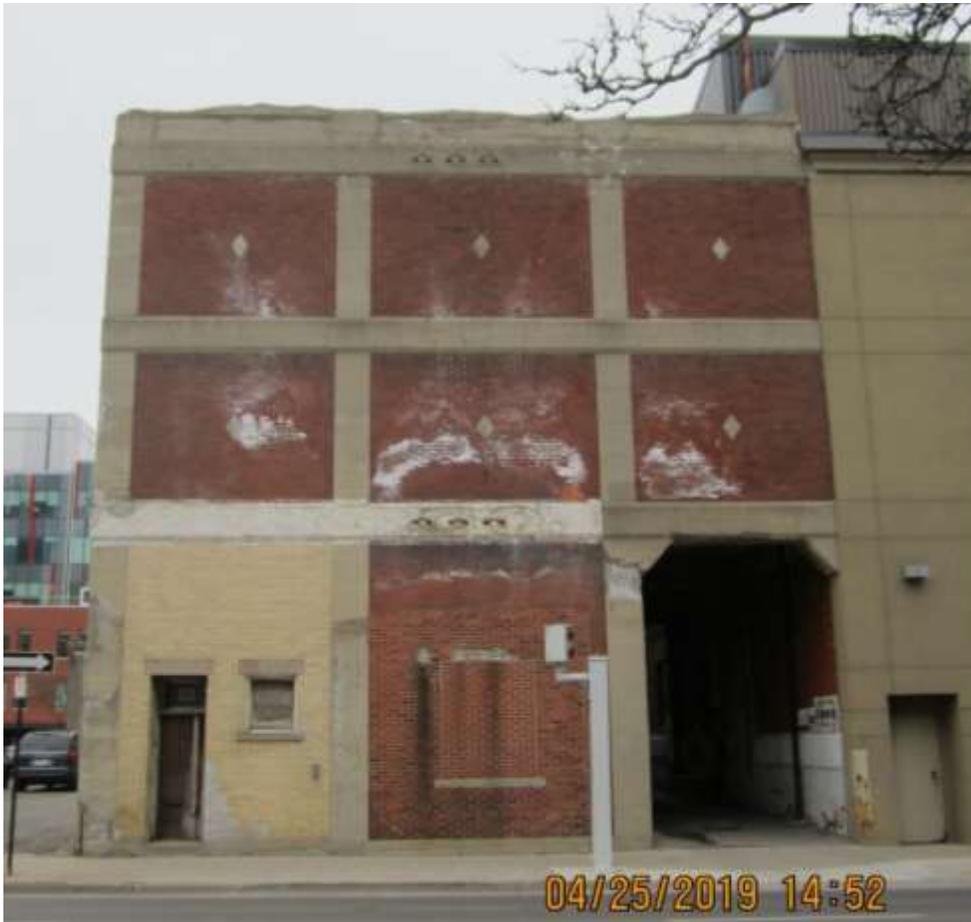
Image 1 – Photo of the front façade of the building located at 123 Queens Avenue (April 25, 2019)

The front façade is clad in red and buff brick with concrete posts and beams and is topped with a concrete parapet. The horizontal beams use to align with the beams at 450 Talbot Street (Appendix B, see Image 4). However, 450 Talbot Street has since been re-cladded. Ornamental concrete diamonds appear on the second and third storey between the concrete posts and beams. The remnants of Cities Heating Company sign and logo can still be seen on the horizontal beam between the first storey and second storey. The first storey has an off-centre entrance with a concrete lintel. A wooden door and transom window with municipal address number is inset from the front façade. Next to the doorway is a window opening with a concrete sill and lintel. Two windows with a concrete lintel have been filled in with red brick next to the laneway. A laneway divides 123 Queens Avenue and 450 Talbot Street at street level, but is connected at the second and third storeys.

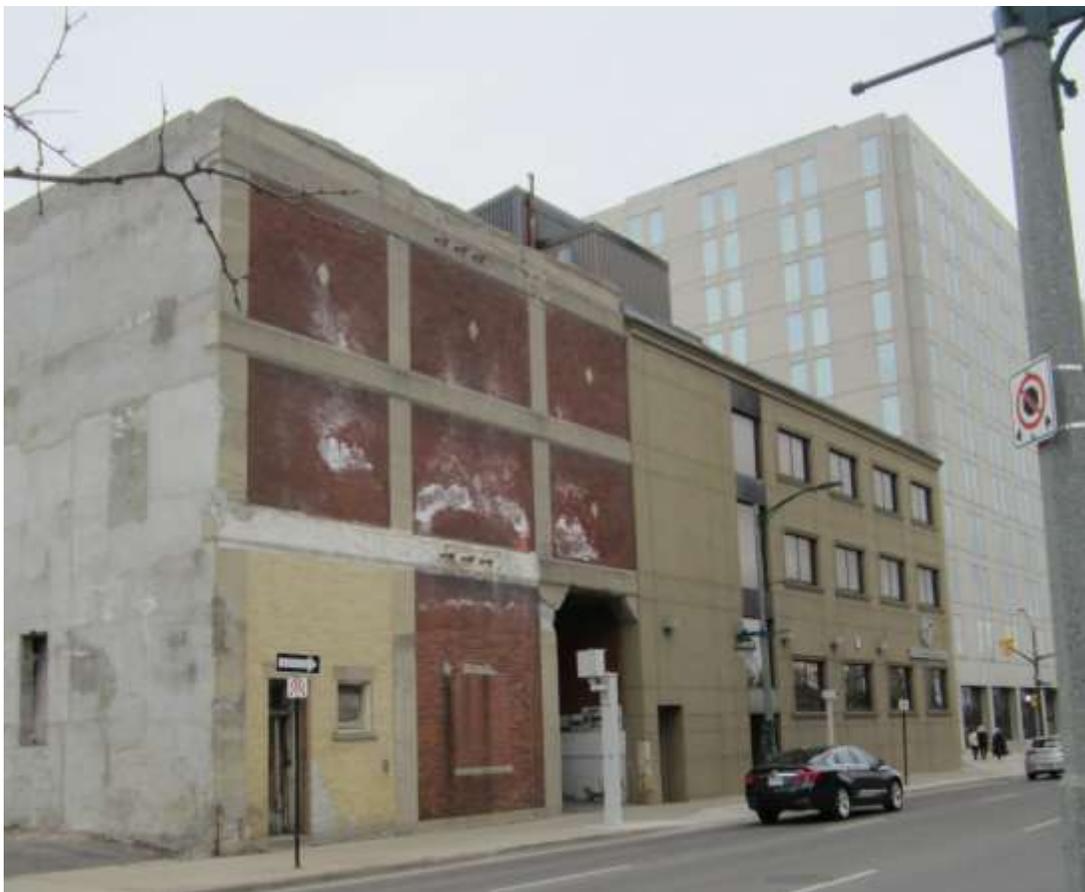
Image 2 – Photo of the front façade of the building located at 123 Queens Avenue (April 25, 2019)

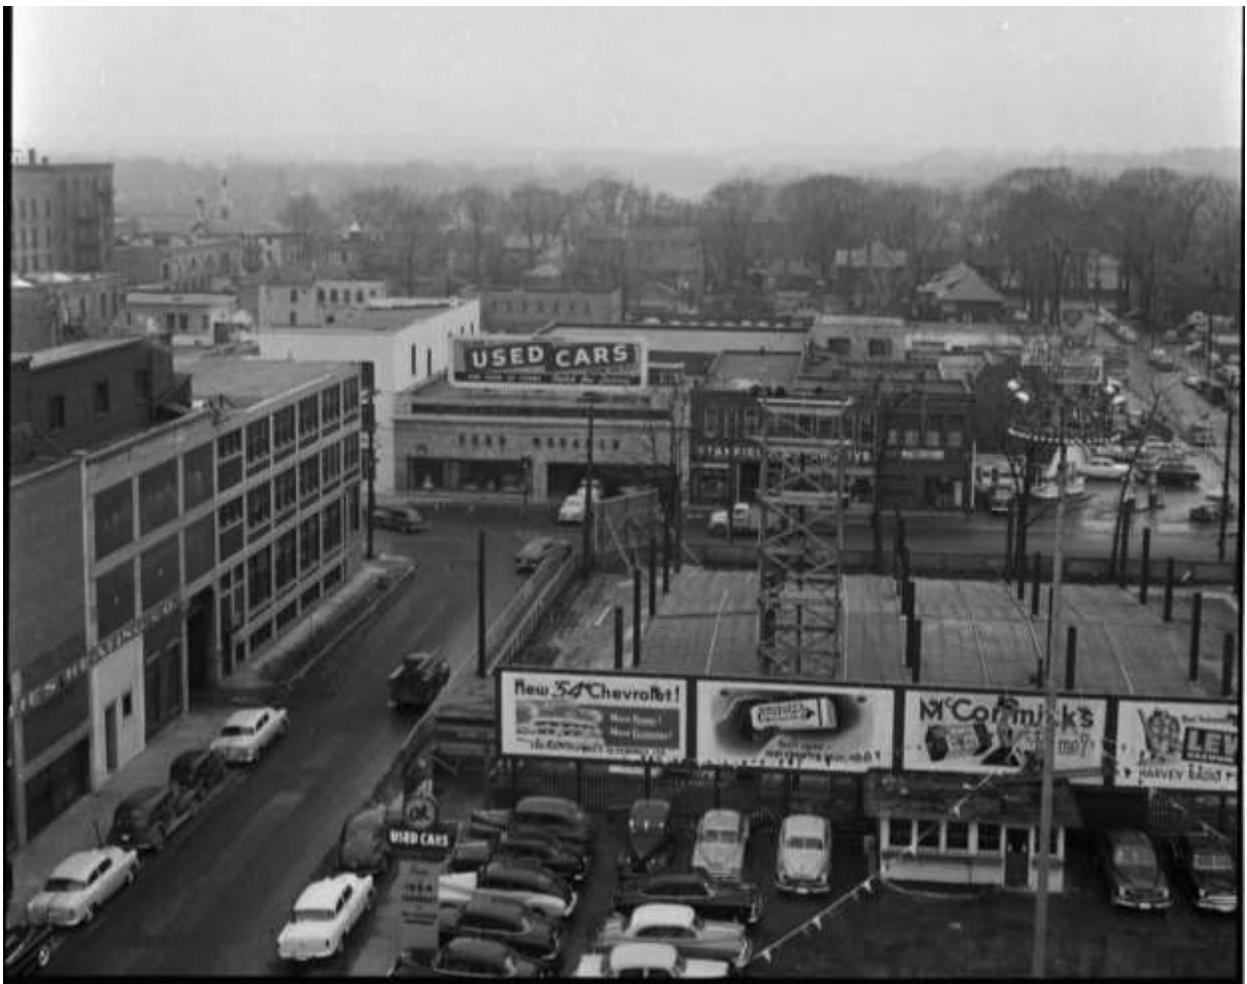
*Image 4 – Photo of the front façade at 123 Queens Avenue looking west from Richmond (London Free Press, 1954).*

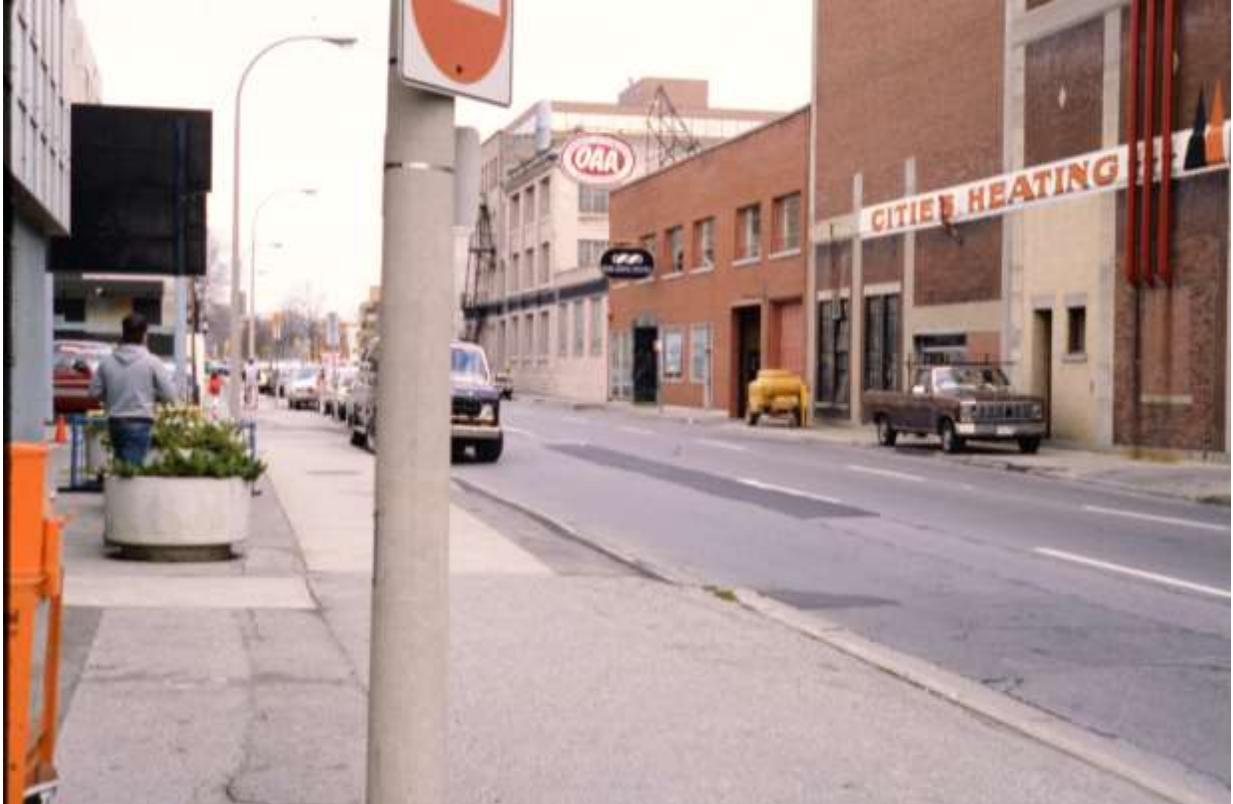
*Image 5 – Photo of the south side of Queens Avenue looking east from Talbot Street. Photo taken prior to 1988. The photo shows the bricked in windows at 123 Queens Avenue, but also shows 3 pipes running into the building through the former openings. The exact date of the photo has not been confirmed, but an aerial from 1988 shows the lot located at 134 Carling Street as vacant, which dates the photo to prior 1988 as the photo shows a building on the property at 134 Carling Street. This means that the windows were bricked in at some point between 1955 and 1988.*

The Heritage Impact Assessment finds that retention in situ is not the preferred option because the health and safety concerns outweigh the retention of the building at 123 Queens Avenue. The health and safety concerns stem from the challenges securing the building. According to the Heritage Impact Assessment “the building has been repeatedly broken into and represents a substantial safety hazard to any unauthorized occupants” (Stantec 7.2). The health and safety concerns outweigh the retention of the building at 123 Queens Avenue because “the building does not contribute significantly to the streetscape” and does not communicate its history due to “the significant modifications in the front façade, including windows that have been closed in with bricks.” (Stantec 7.2).
