MEMO

Re: **Ferndale Ave Bike Lane Barriers**

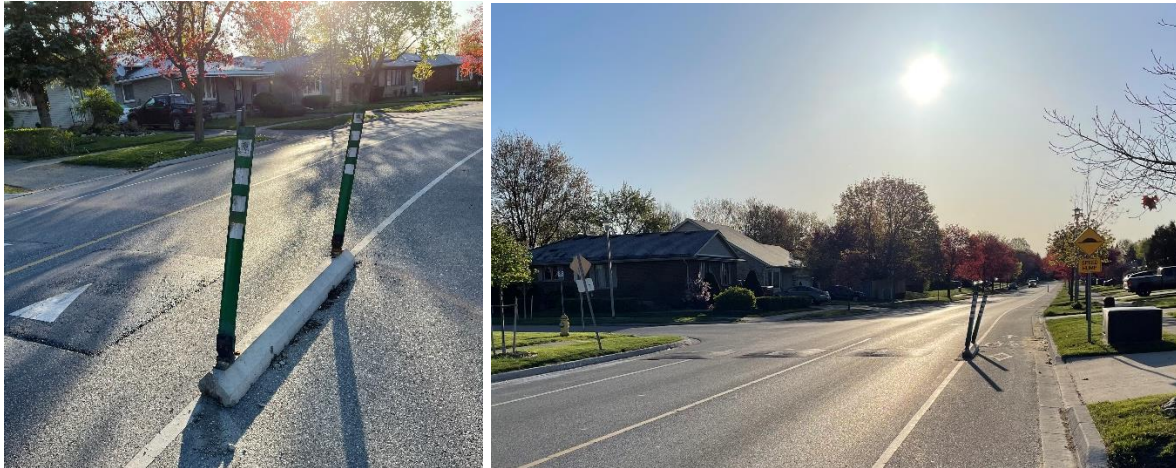
In 2020, a concrete curb with bollards, see pictures above, were installed on Ferndale Ave adjacent to the speed cushions in three locations. This was an all-year solution that kept vehicles out of the bike lane, preserved the usefulness of the speed cushions and increased the safety for people on bikes.

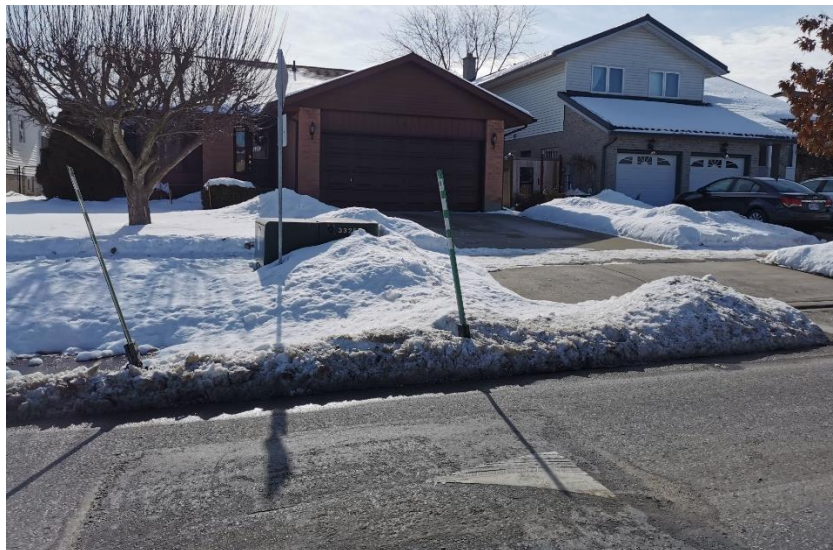
The drawbacks of the concrete curb solution, like any barrier in the roadway, is that it reduced maintenance efficiency. In the winter, the road plow is forced to plow a windrow across the bike lane, causing snow accumulation in the bike lane, see picture below.

This reduces the effectiveness of removing the snow from the roadway and adds additional maintenance costs to return to the area to clear these specific locations. In the summer, road sweeping is also more difficult with the barriers installed.
