Report to Planning and Environment Committee

Subject: Heritage Alteration Permit application by the Incorporated
Synod of the Diocese of Huron at 472 Richmond Street, Part
IV and Downtown Heritage Conservation District

Conservation Plan: 472 Richmond Street, St. Paul's Cathedral - the "Beaver Fence"
Downtown Loop Bus Rapid Transit and Infrastructure Improvements

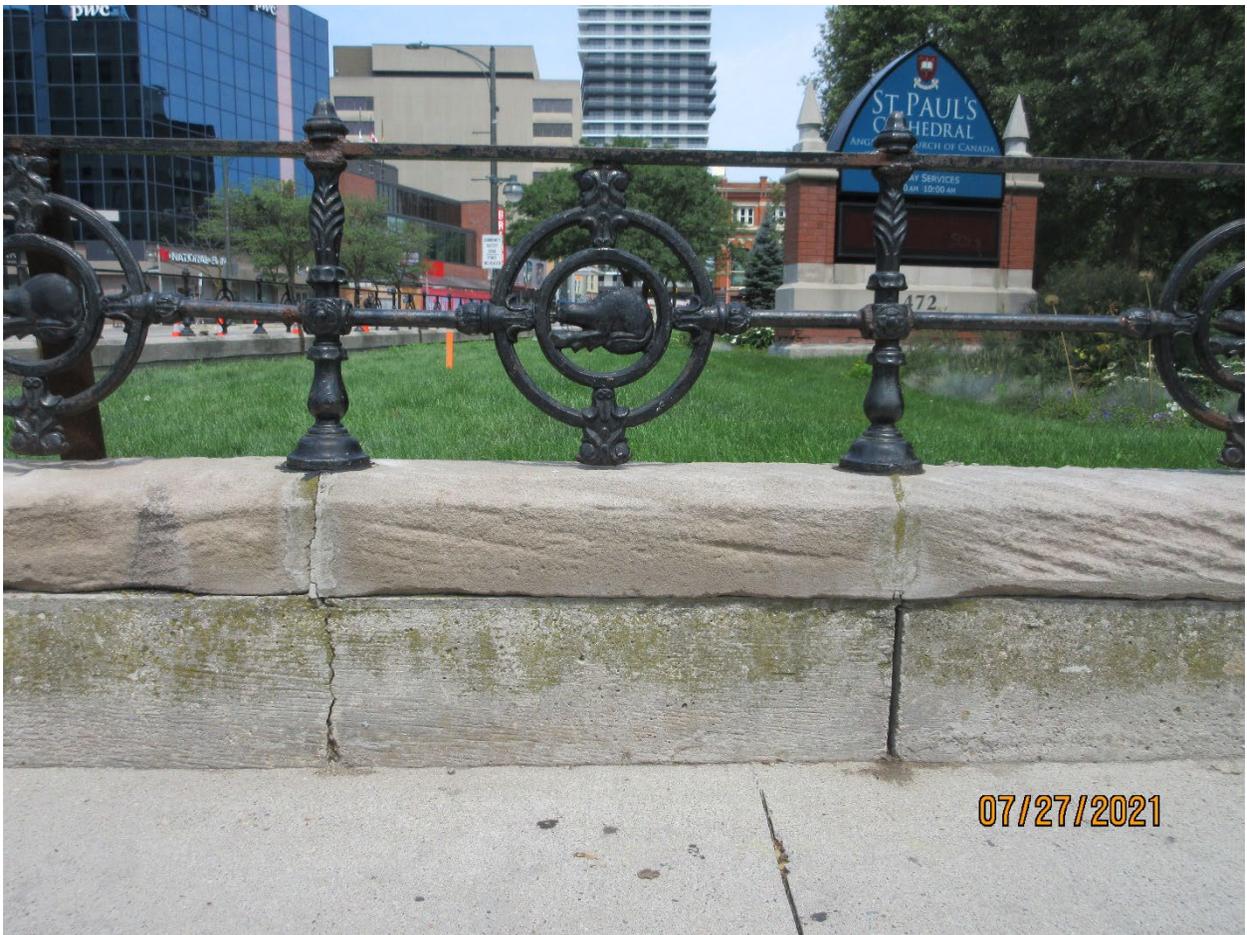
Image 4: Detail view of a typical panel of the beaver fence, composed of its cast iron posts, rails, and medallions, sandstone cap stones, and concrete foundation.

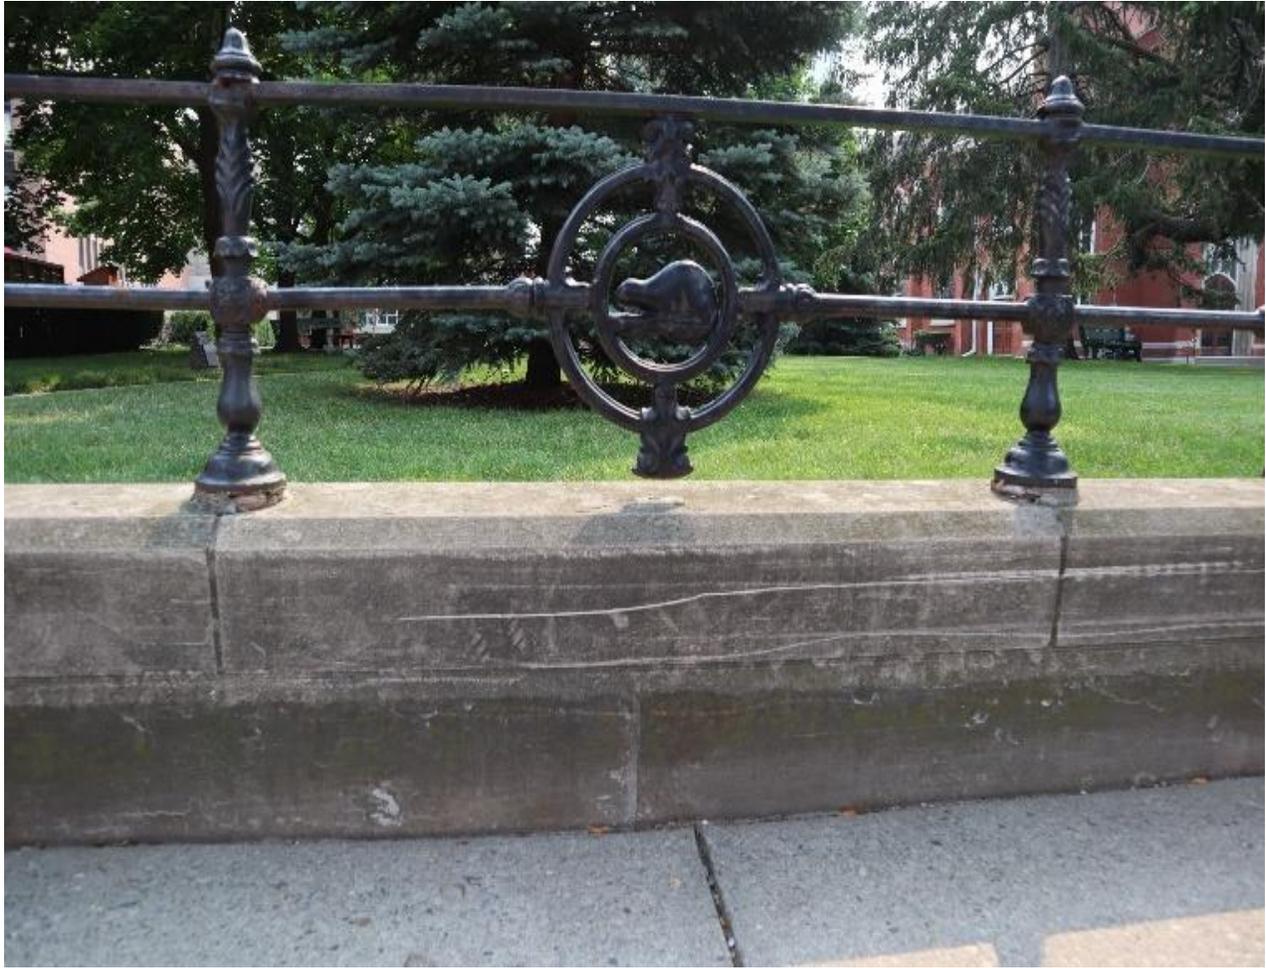
Photograph 12:
Sandstone cap stones and concrete foundation of the fence on Richmond Street, south side of the main entrance path
(AECOM, July 2021)

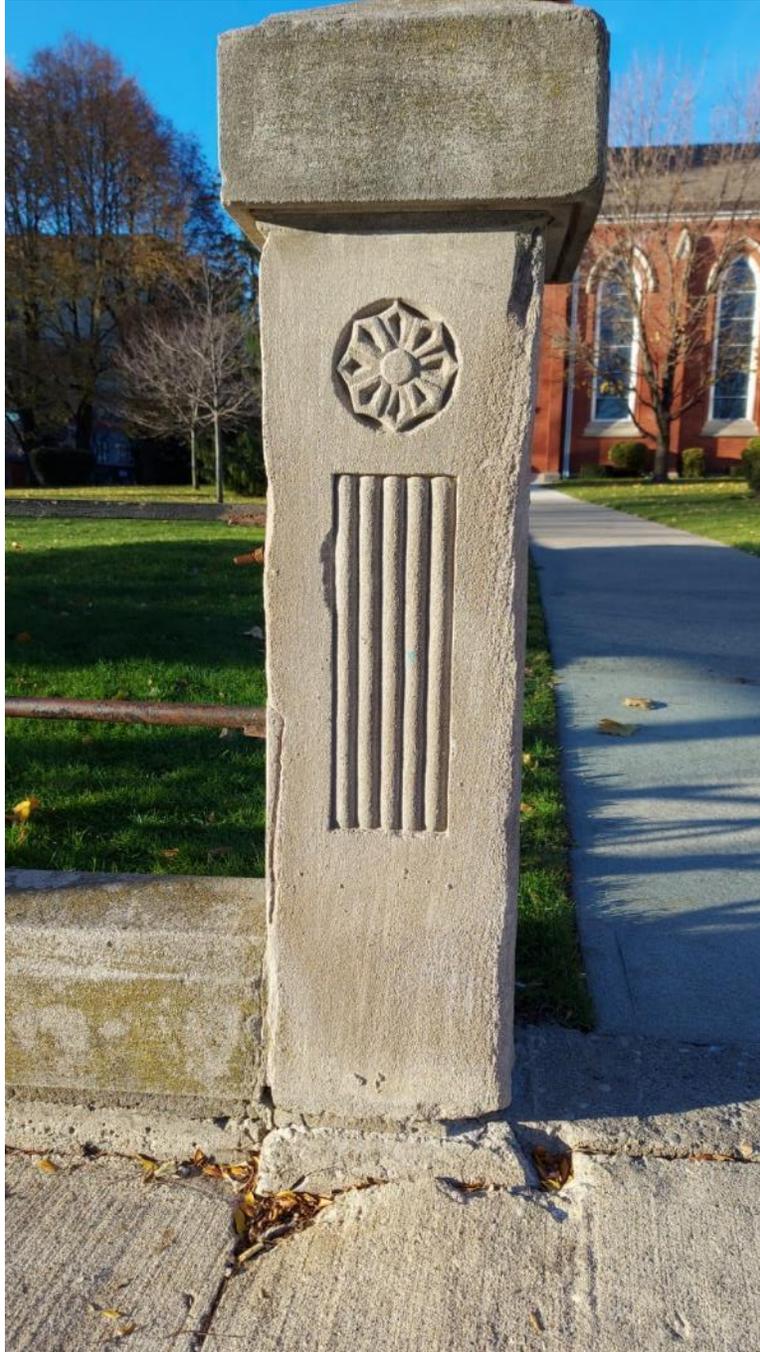
Photograph 15: End post proposed for relocation on Queens Avenue, showing signs of weathering and localized weathering on corners (AECOM, November 2021)

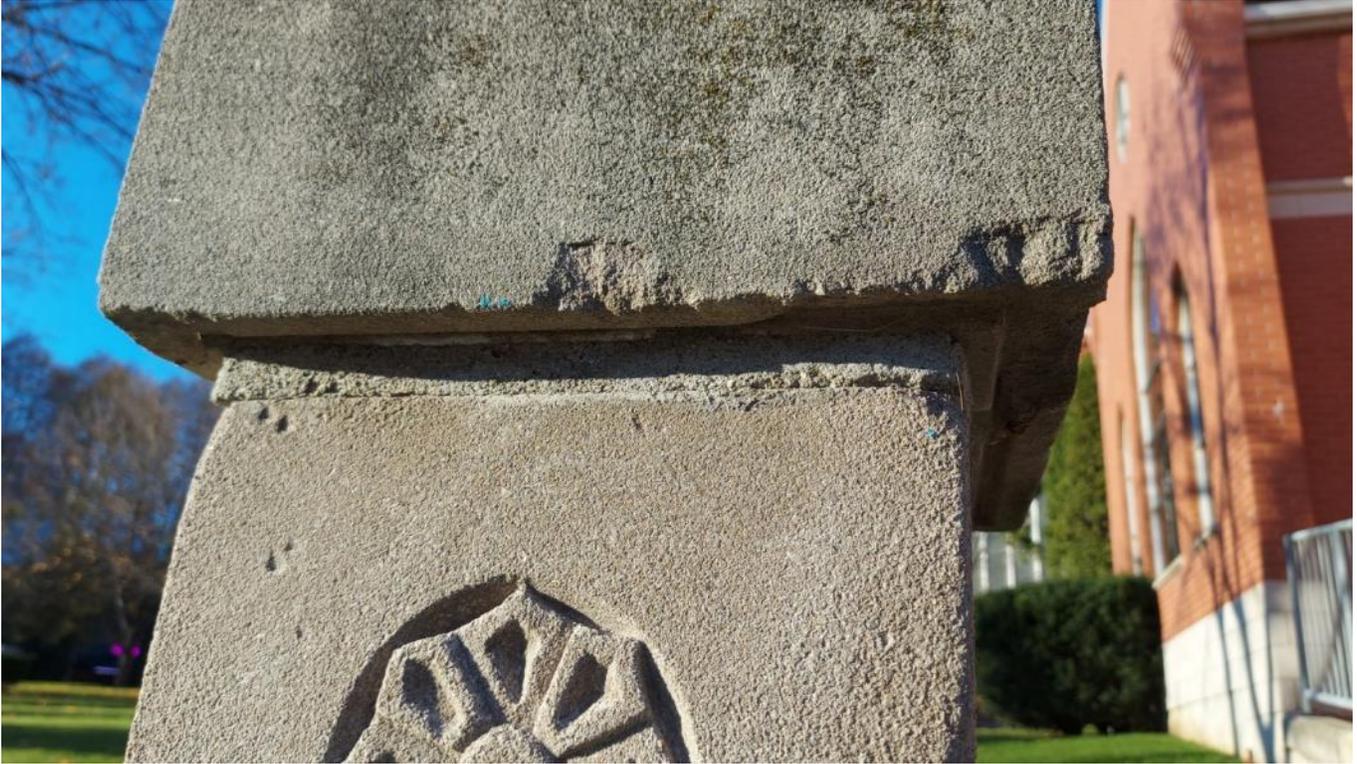
Photograph 16: View of the separate top cap of the end post with mortar layer with the end post (AECOM, November 2021)

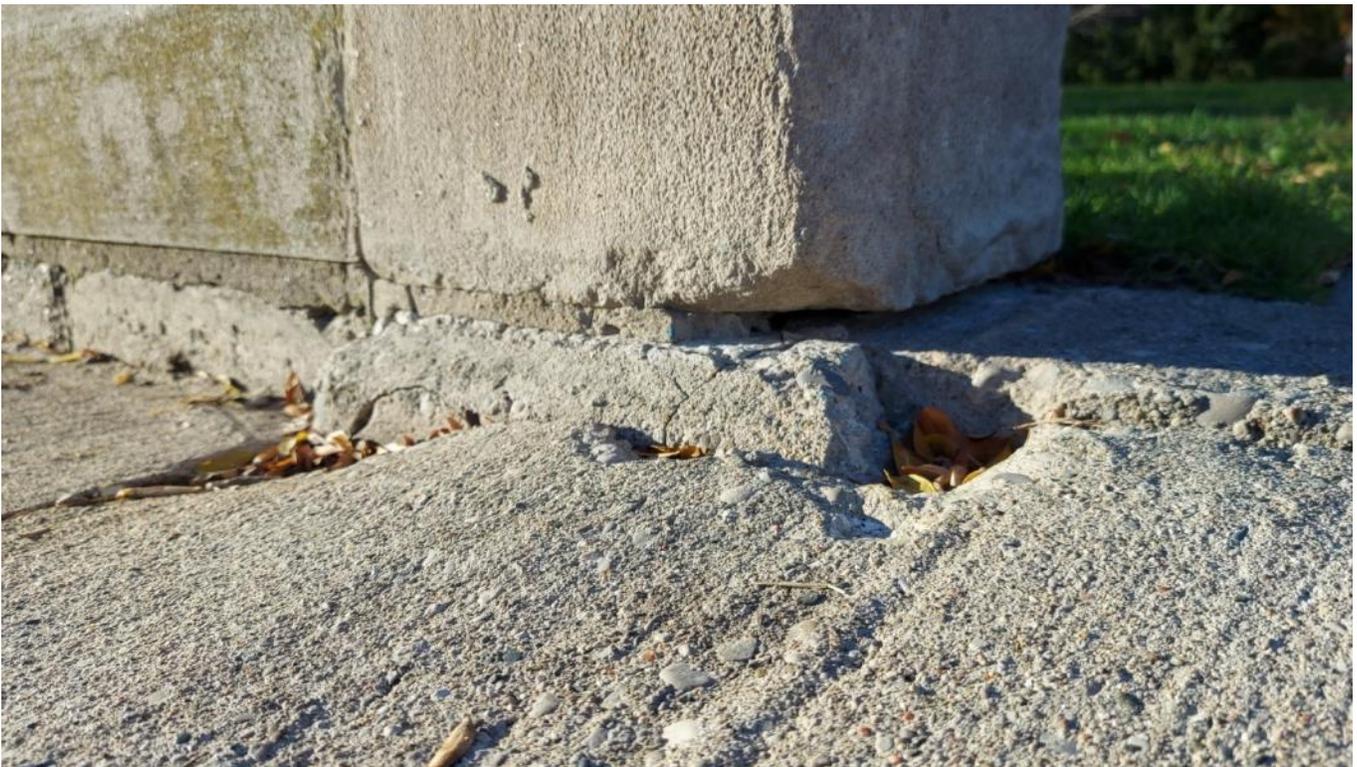
Photograph 17: End post placed on a mortar layer with a concrete foundation (AECOM, November 2021)

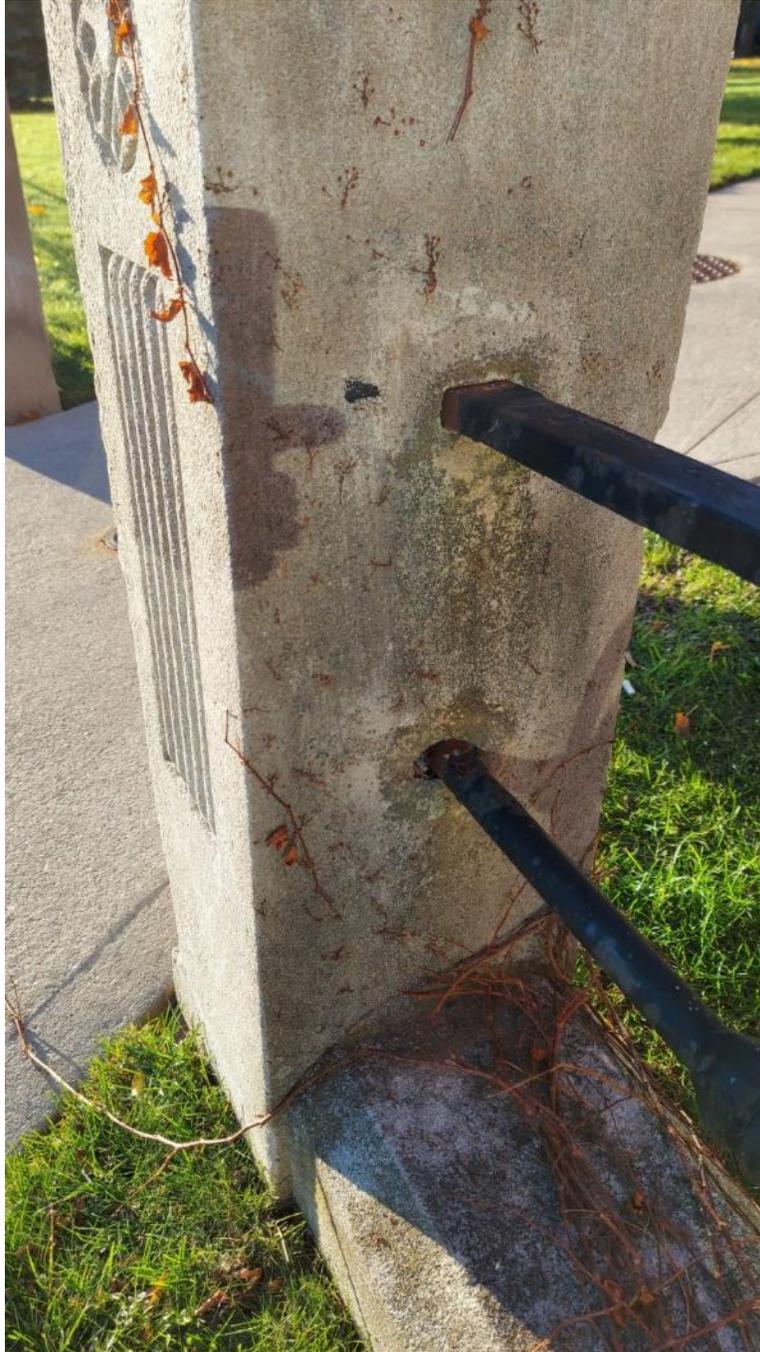
Photograph 19: Modified horizontal rails which place reinforcing steel bars into holes with mortar and welding of reinforcing steel bars to horizontal rails (AECOM, November 2021)

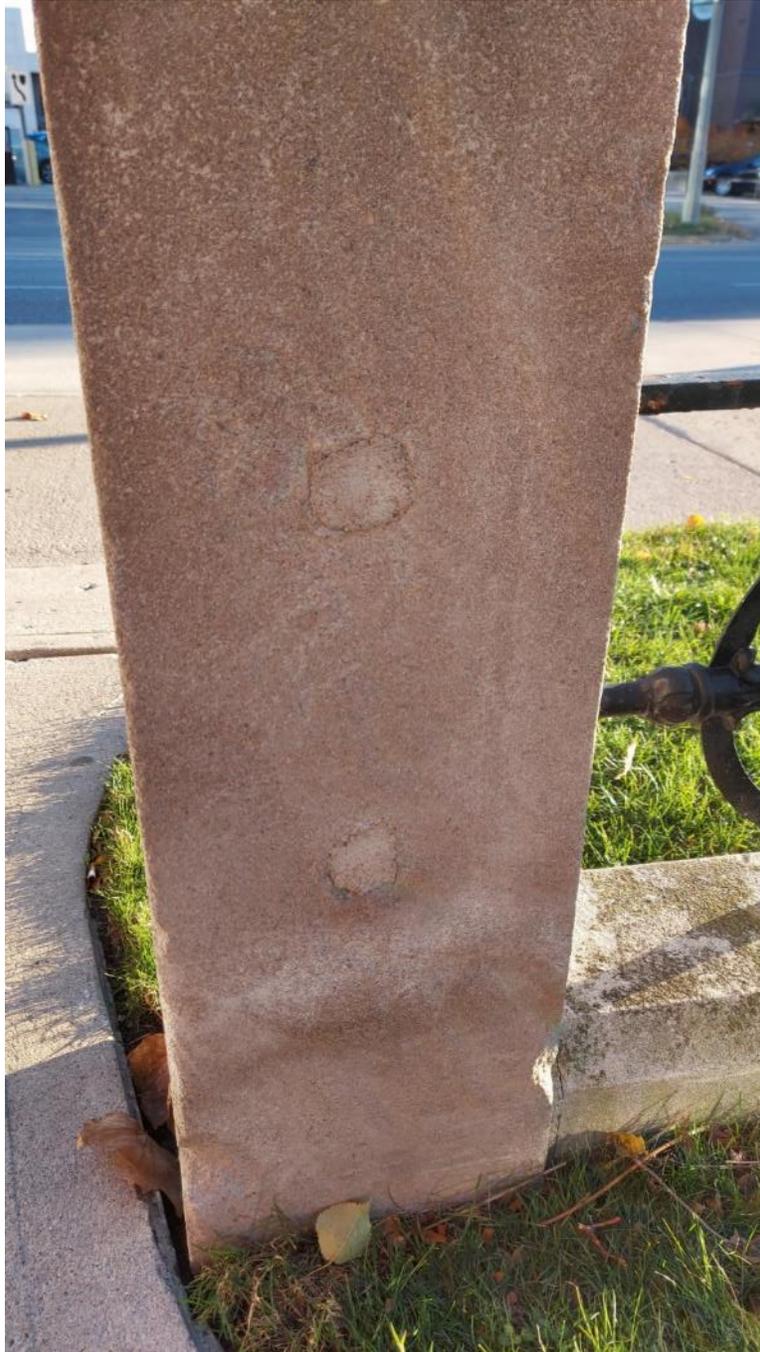
Photograph 20: Former holes in the end posts (for horizontal rail attachment) that were patched up, potentially indicating the end post was turned for repairs (AECOM, November 2021)

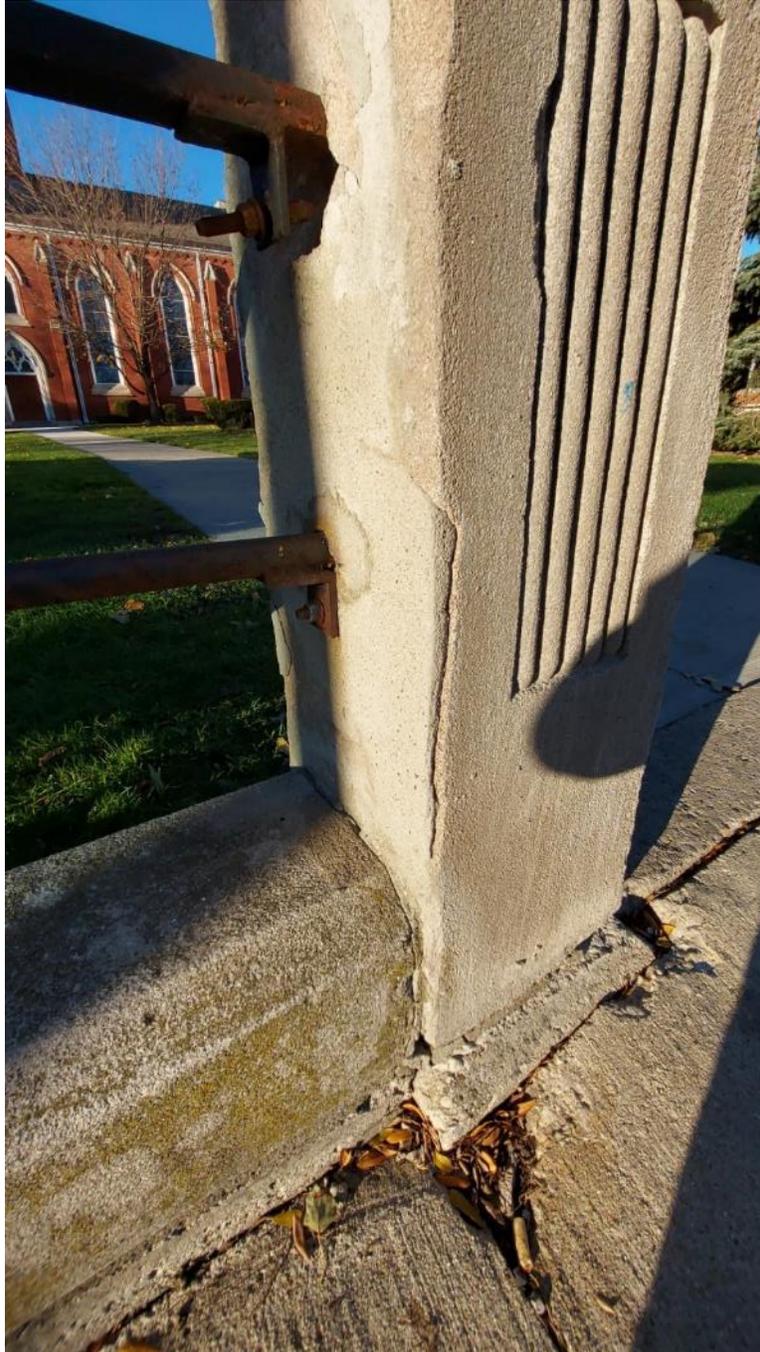
Photograph 21: End post with localized repairs (AECOM, November 2021)

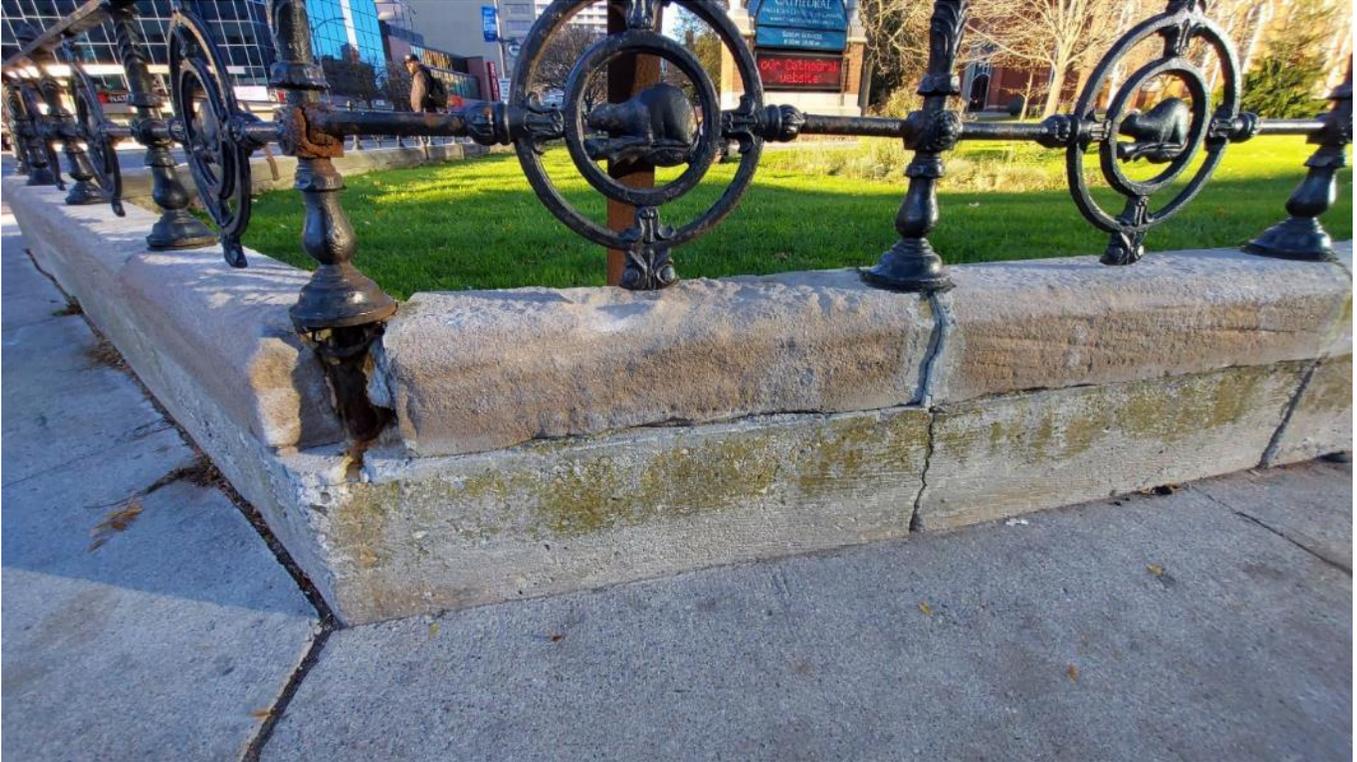
Photograph 22: Example of a cap stone in poor condition (AECOM, November 2021)

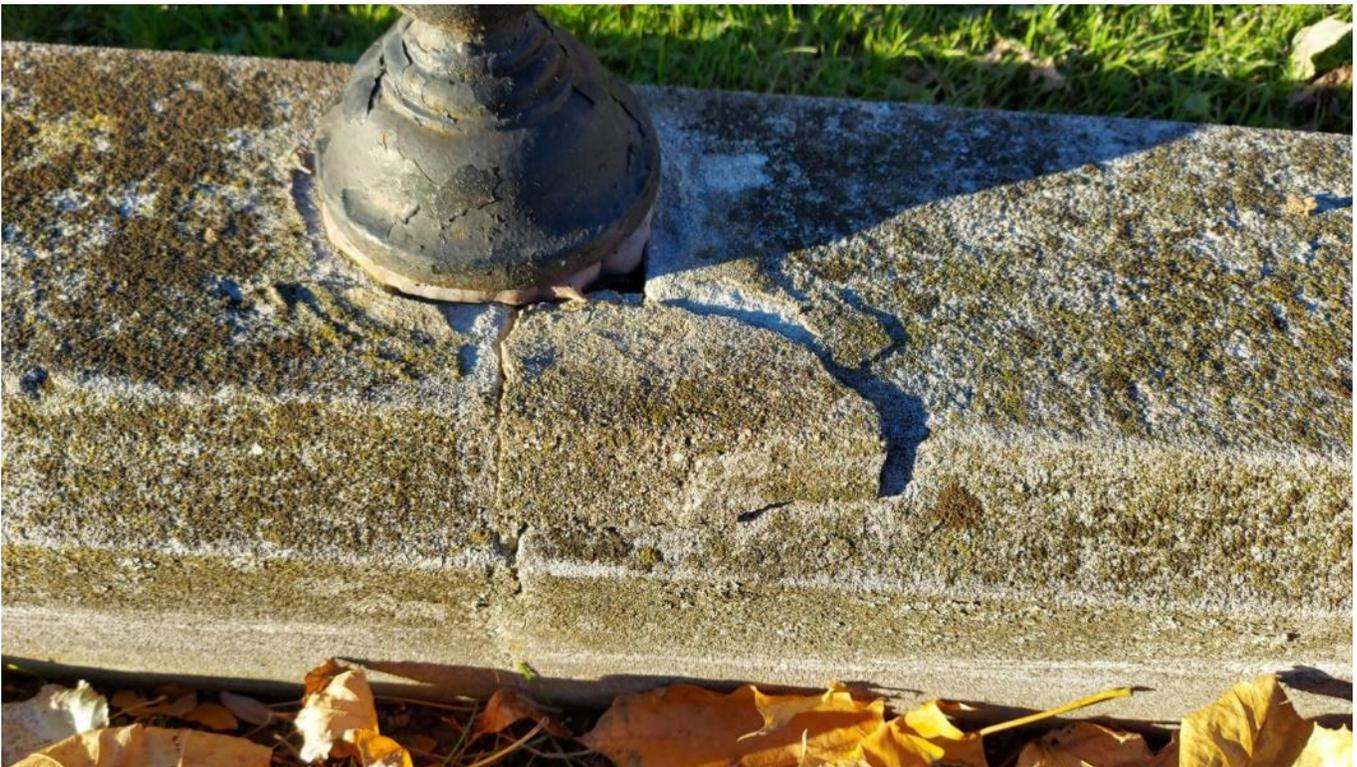
Photograph 23: Capstone cracking and spalling (AECOM, November 2021)

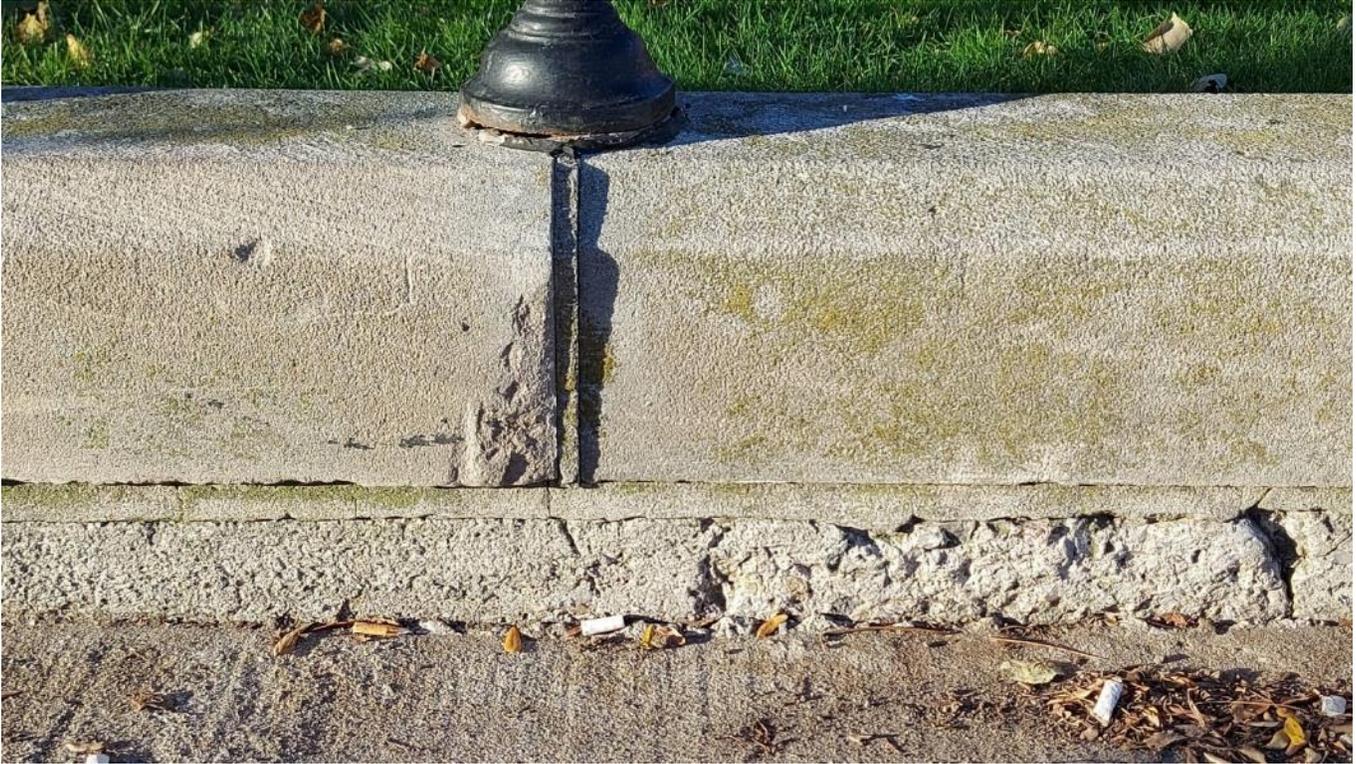
Photograph 24: View of mortar joint between cap stone and concrete foundation and mortar joint at each vertical rail post location (AECOM, November 2021)

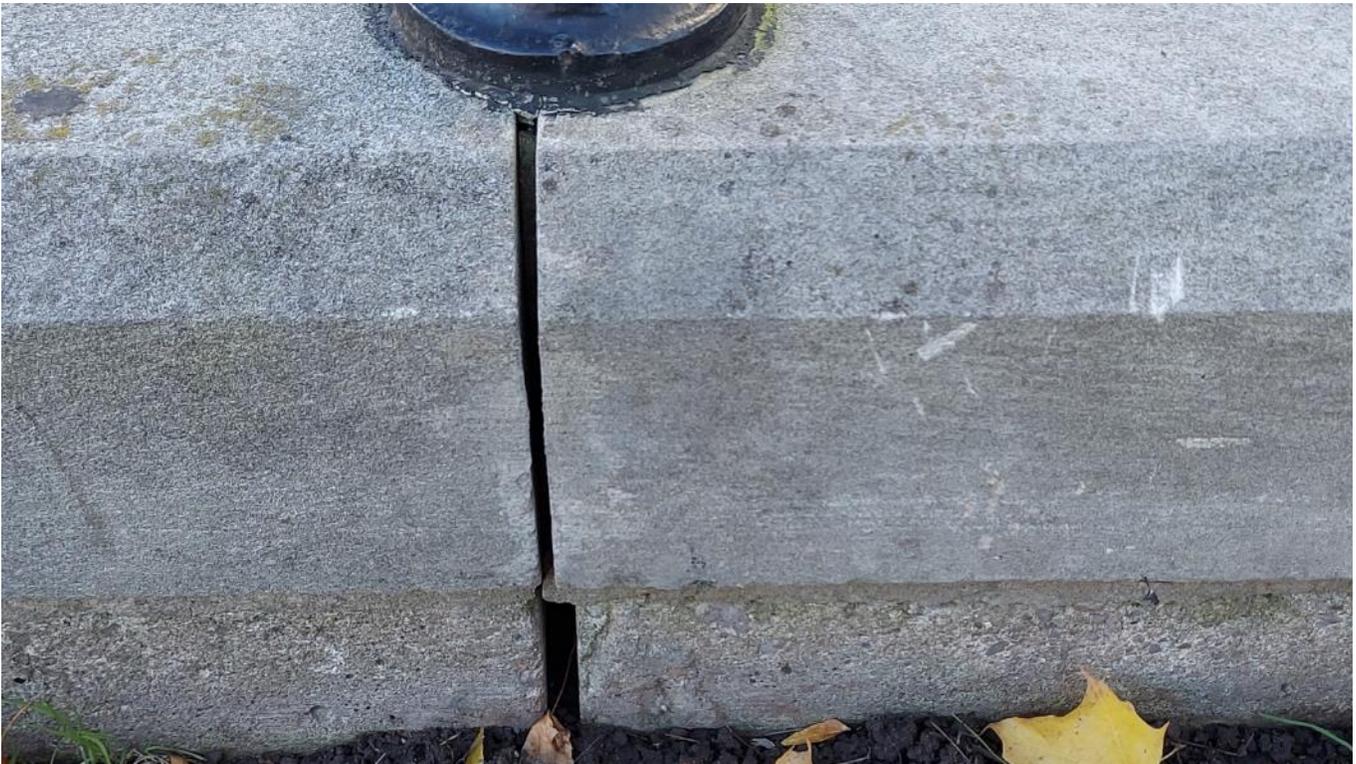
Photograph 25: Example of mortar joint missing and the cap stone cut and notched at each joint to accommodate the post attachment (AECOM, November 2021)

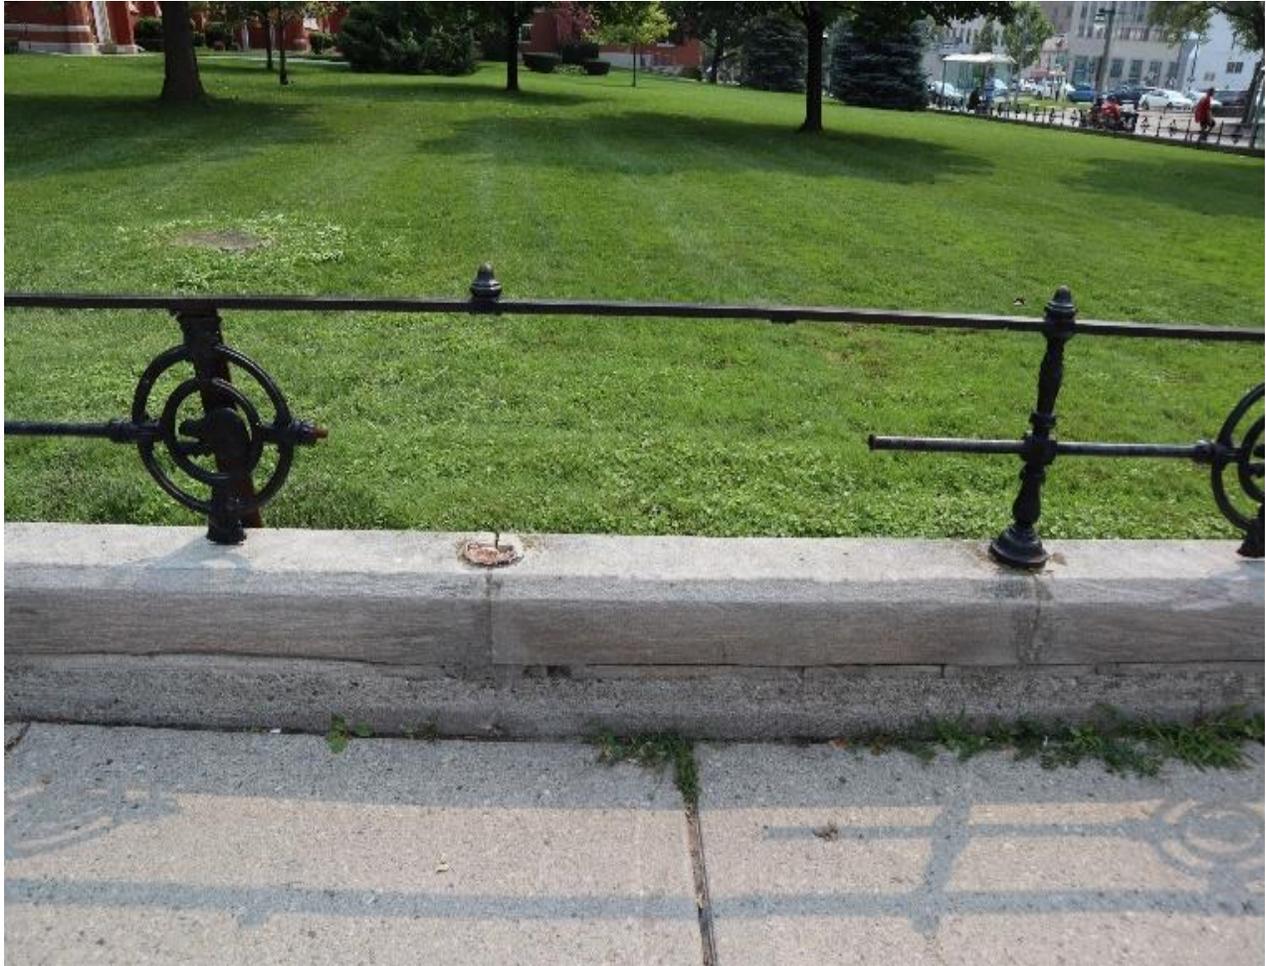
Photograph 26:Missing section of the beaver fence on Richmond Street (AECOM, May 2021)

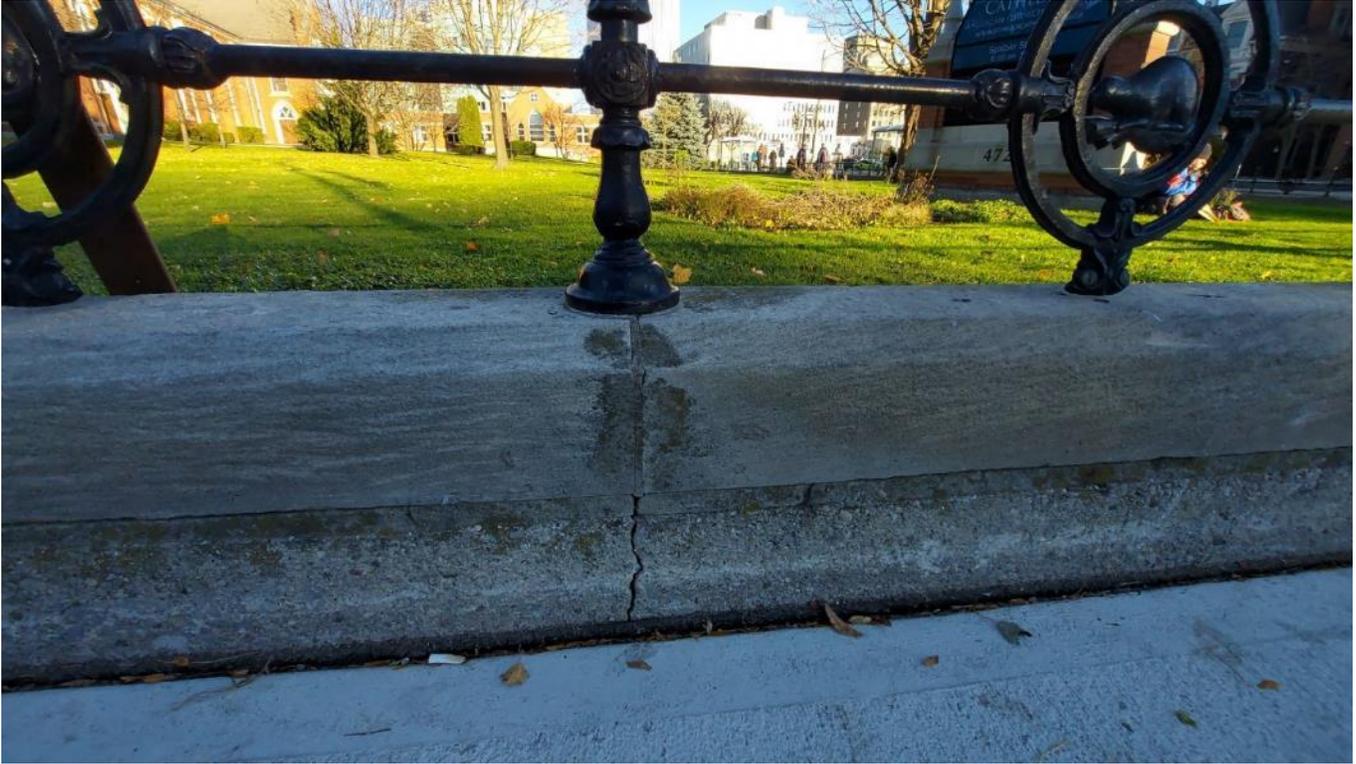
Photograph 27: Caulking below the base of the post to increase contact and seal area below (AECOM, November 2021)

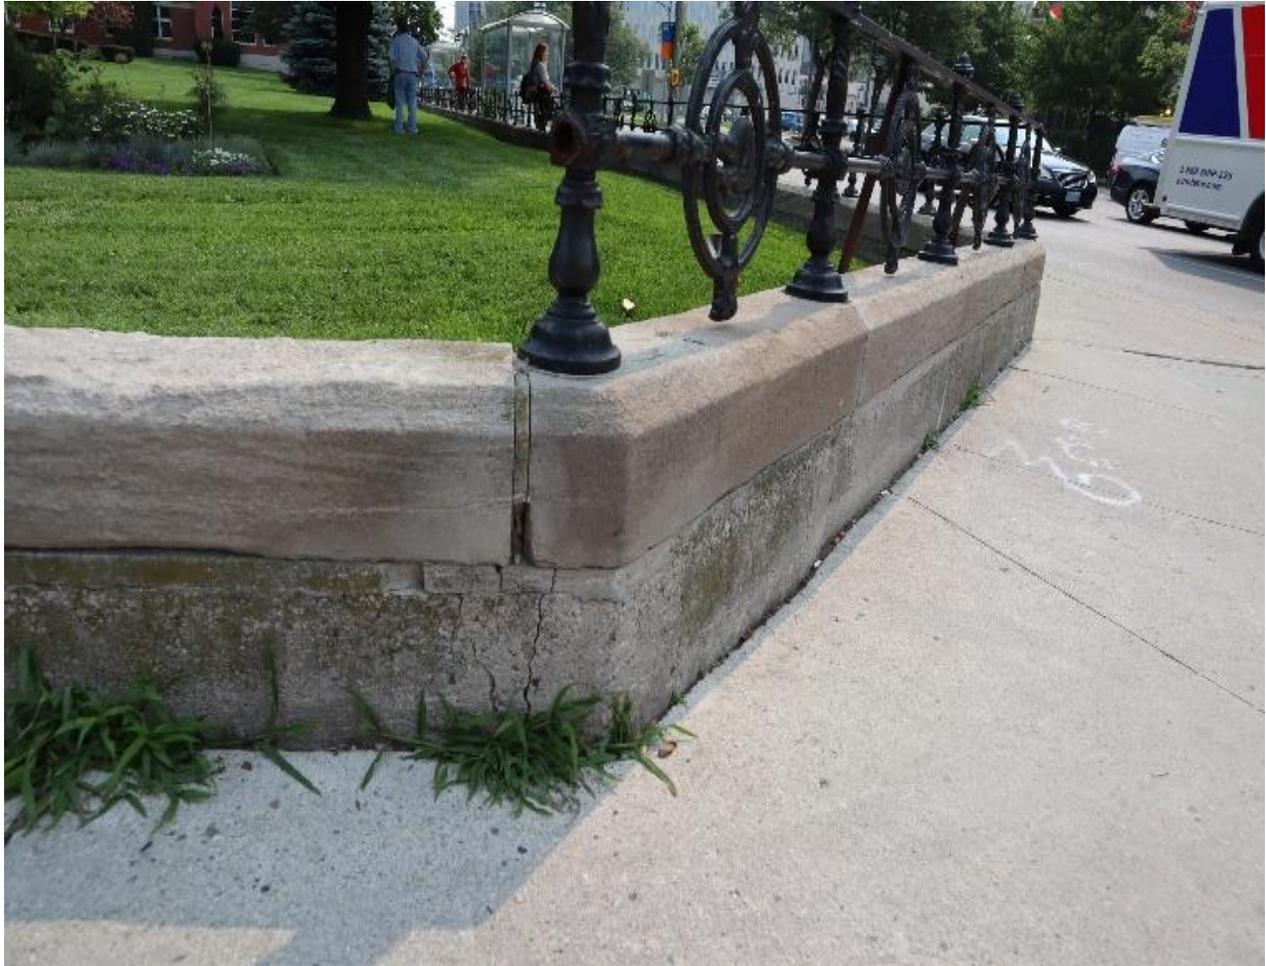
Photograph 28: Details of a corner of the beaver fence (AECOM, May 2021)

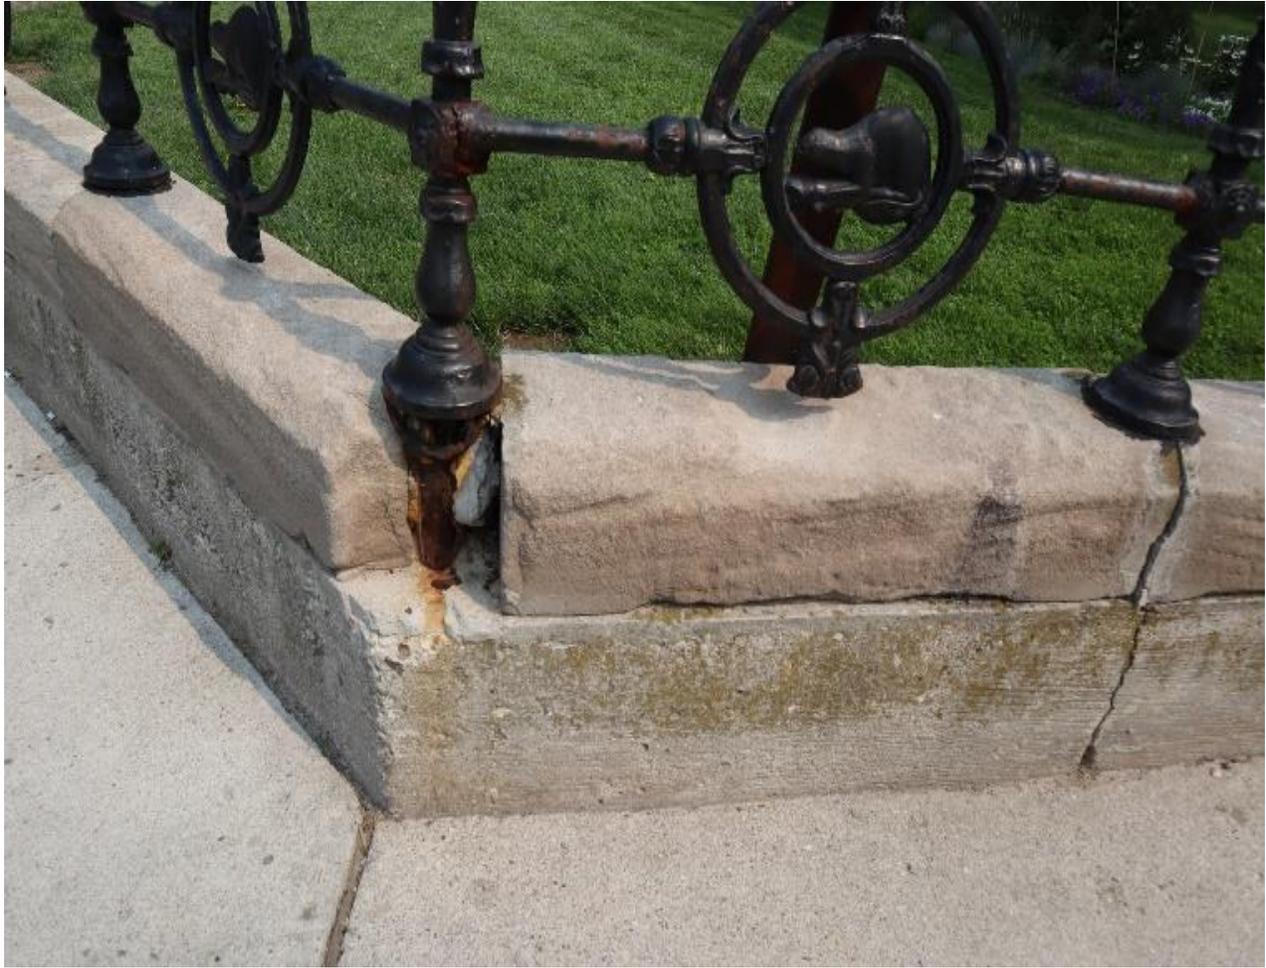
Photograph 29: Pin tie of a vertical rail post (AECOM, May 2021)

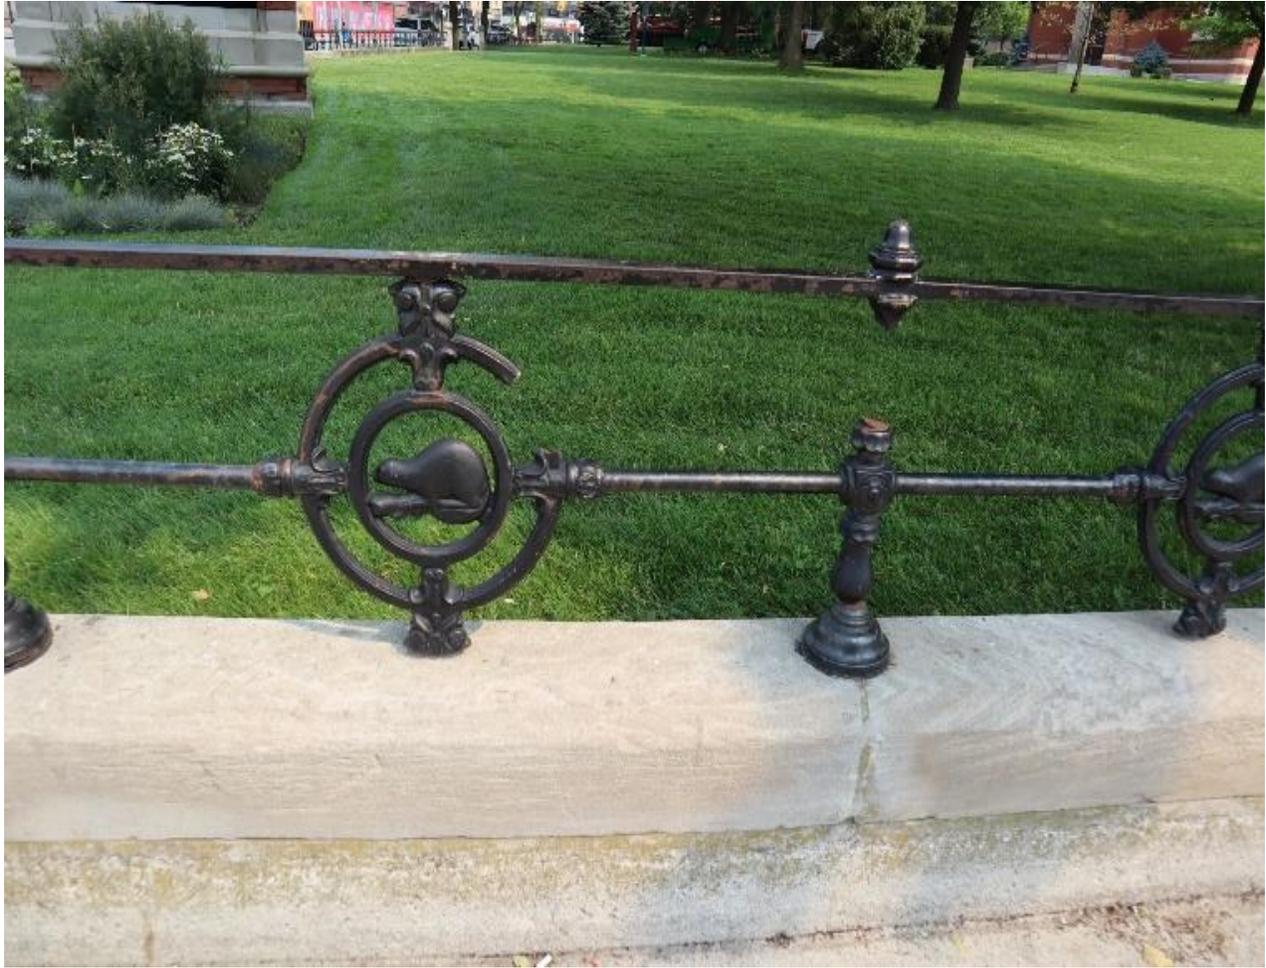
Photograph 30: Damaged section of the beaver fence on Richmond Street (AECOM, May 2021)

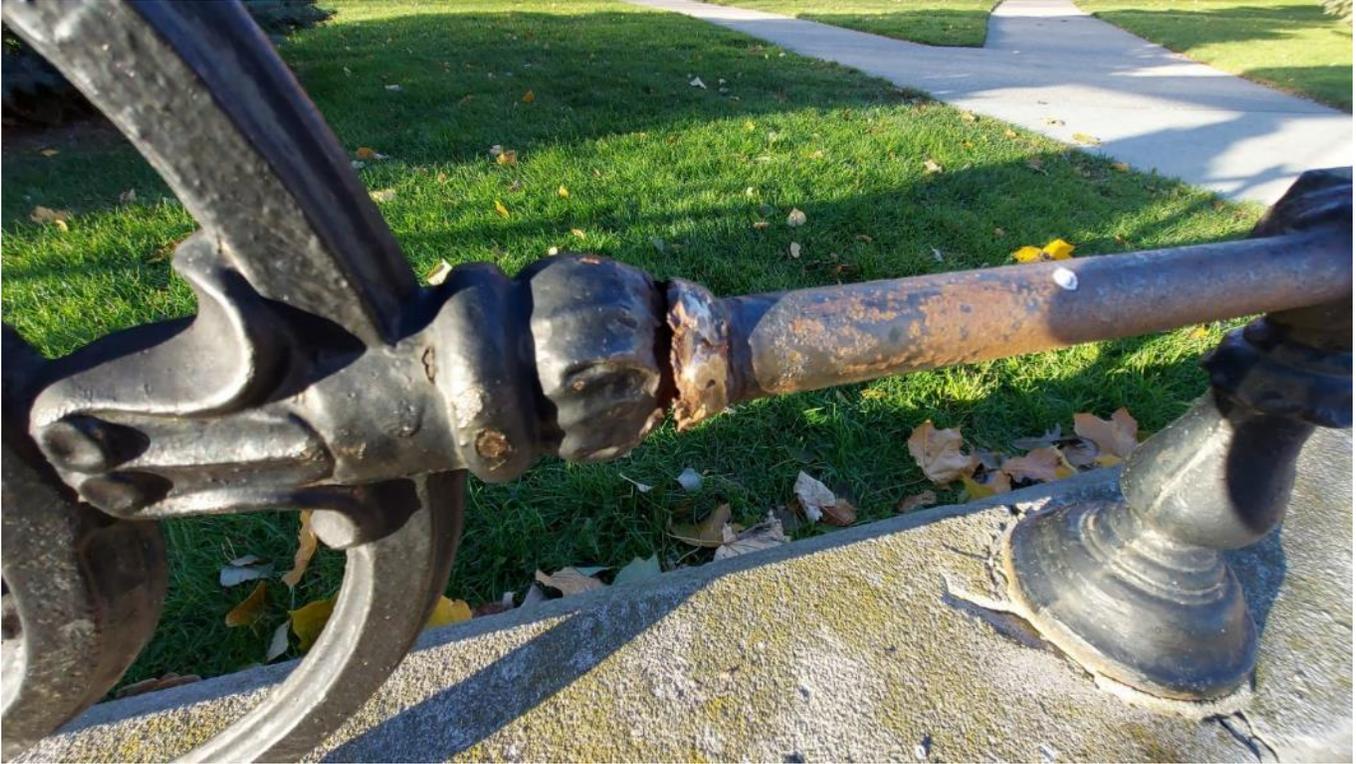
Photograph 31: The mid horizontal rail inserted into the ends of the beaver medallion and into the receiving ends of the vertical posts. The tube is welded at each location (AECOM, November 2021)

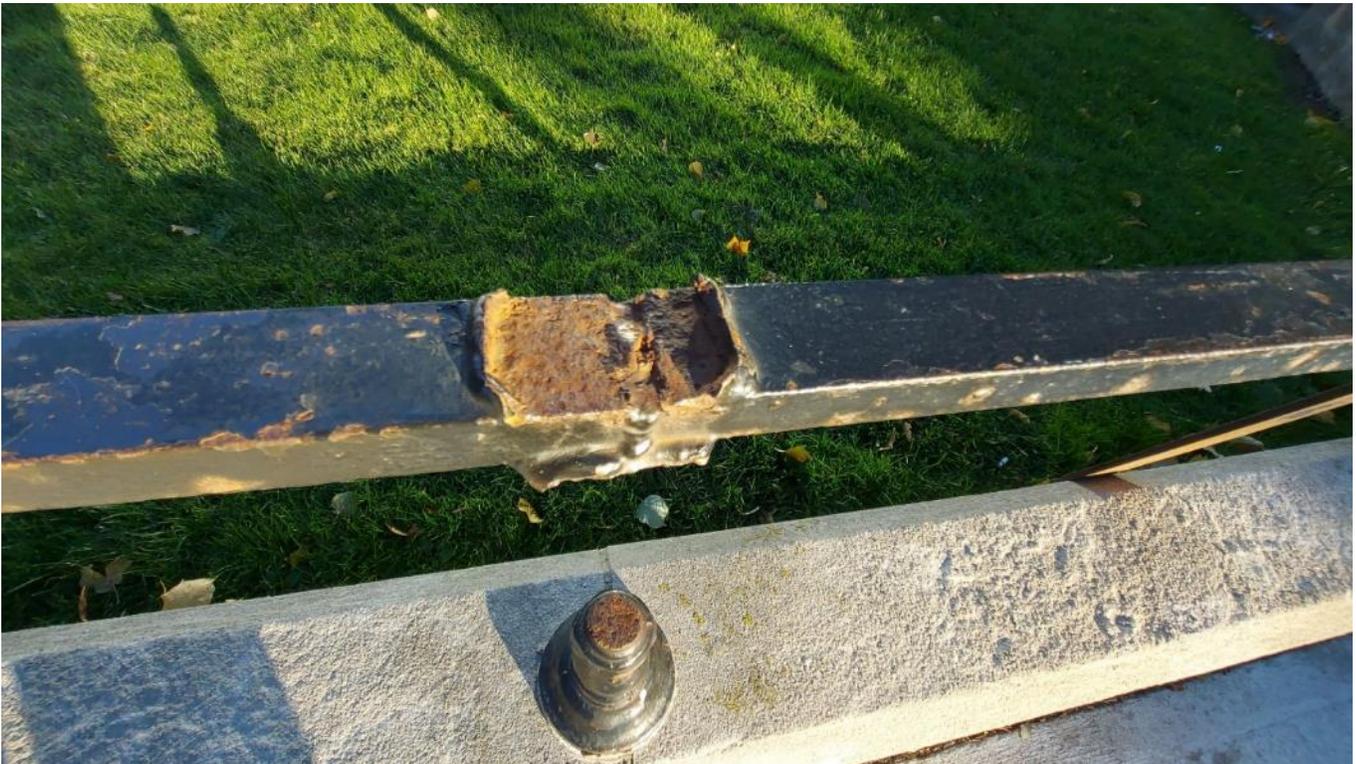
Photograph 32: The flat horizontal bar was placed over the vertical rail post and welded (AECOM, November 2021)

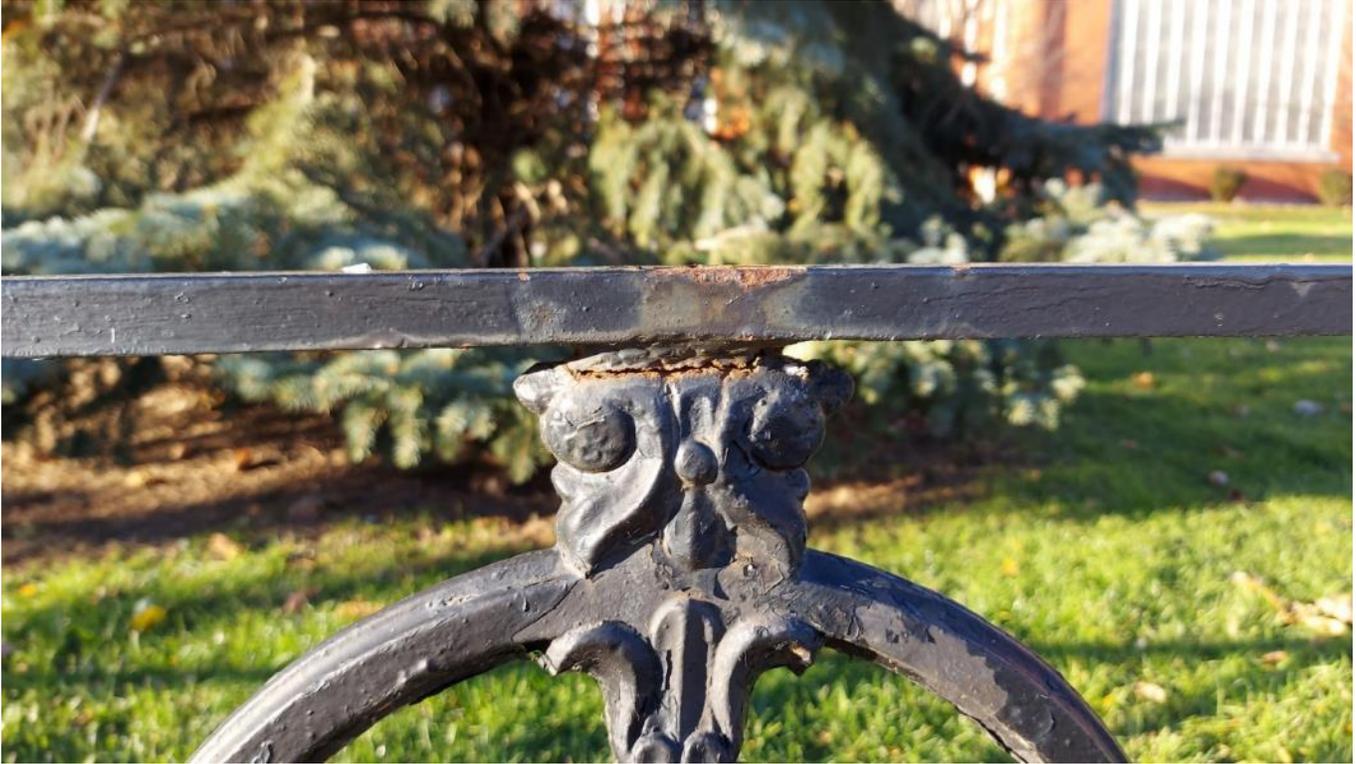
Photograph 33: Beaver medallion welded to top horizontal rail (AECOM, November 2021)
