Report to Planning and Environment Committee

Subject: Heritage Alteration Permit application by the Incorporated
Synod of the Diocese of Huron at 472 Richmond Street, Part
IV and Downtown Heritage Conservation District

Conservation Plan: 472 Richmond Street, St. Paul's Cathedral - the "Beaver Fence"
Downtown Loop Bus Rapid Transit and Infrastructure Improvements

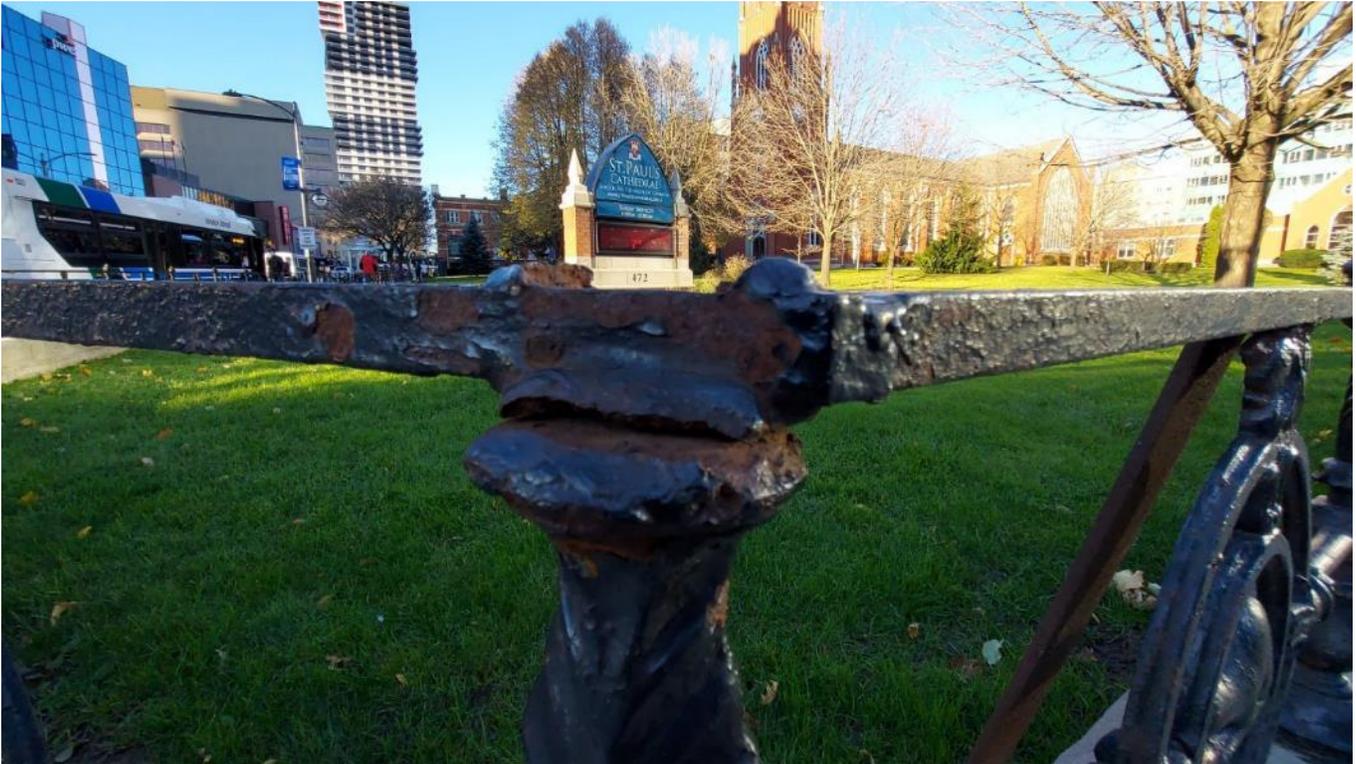
Photograph 34: Welding with cracks, illustrating piece by piece on-site construction of fence (AECOM, November 2021)

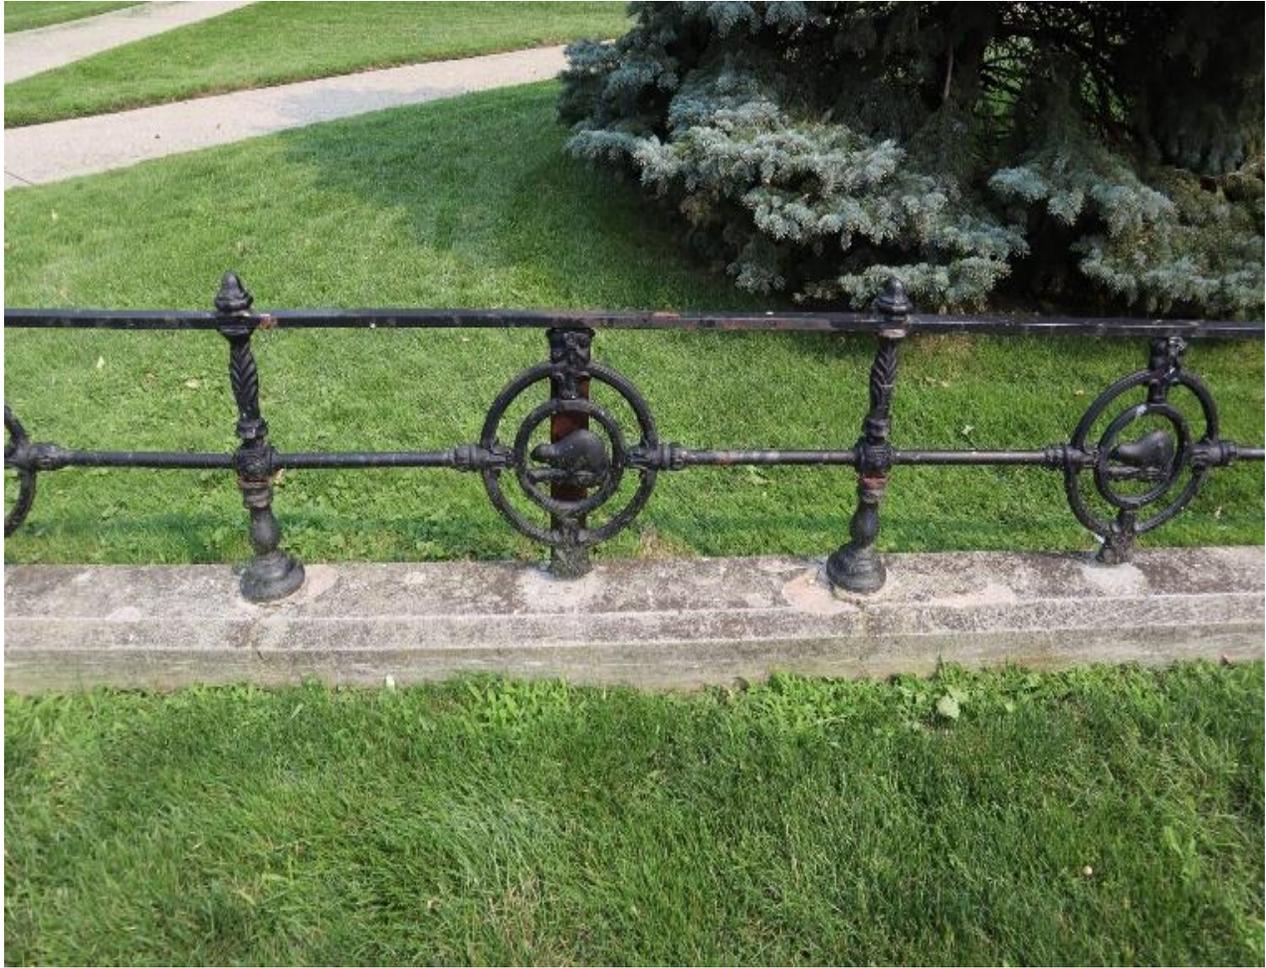
Photograph 35: View of the beaver fence on Queens Avenue with buried foundation (AECOM, May 2021)

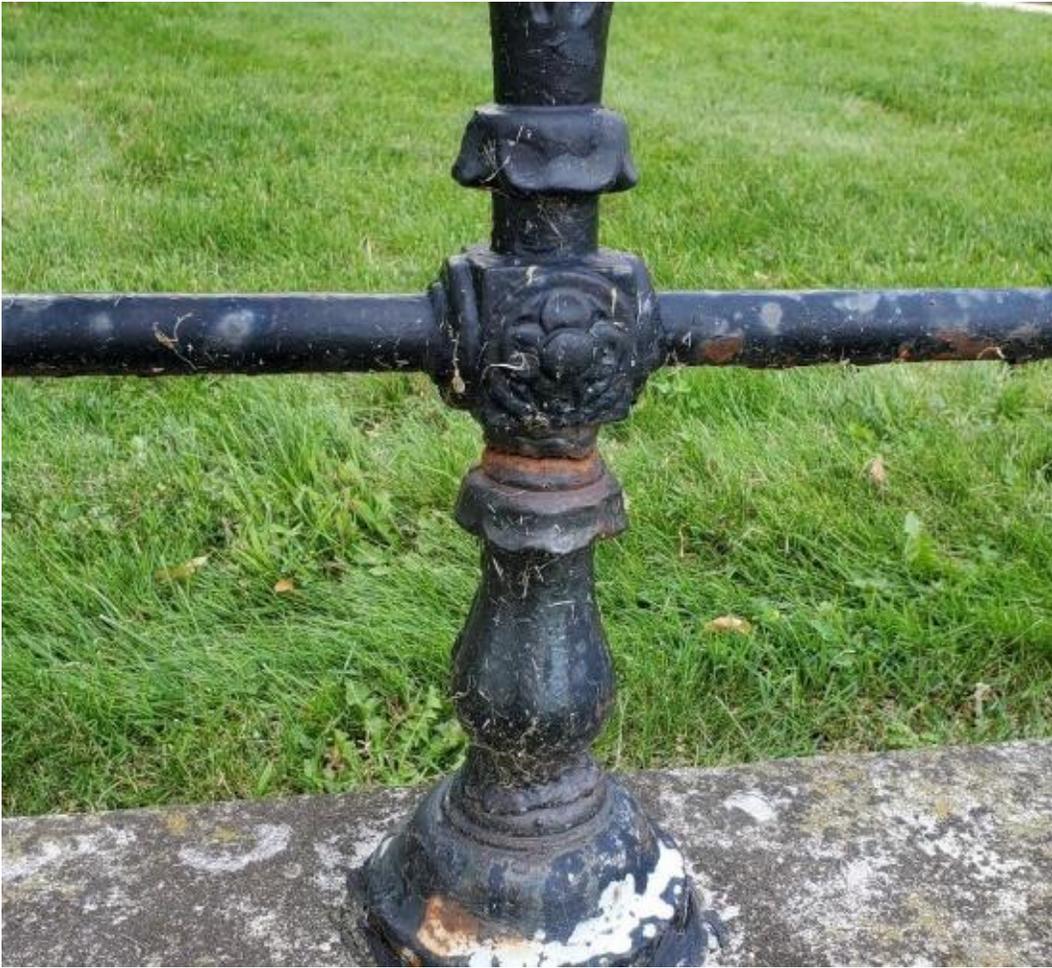
Photograph 38: Floral motif of the vertical rail post (AECOM, July 2021)

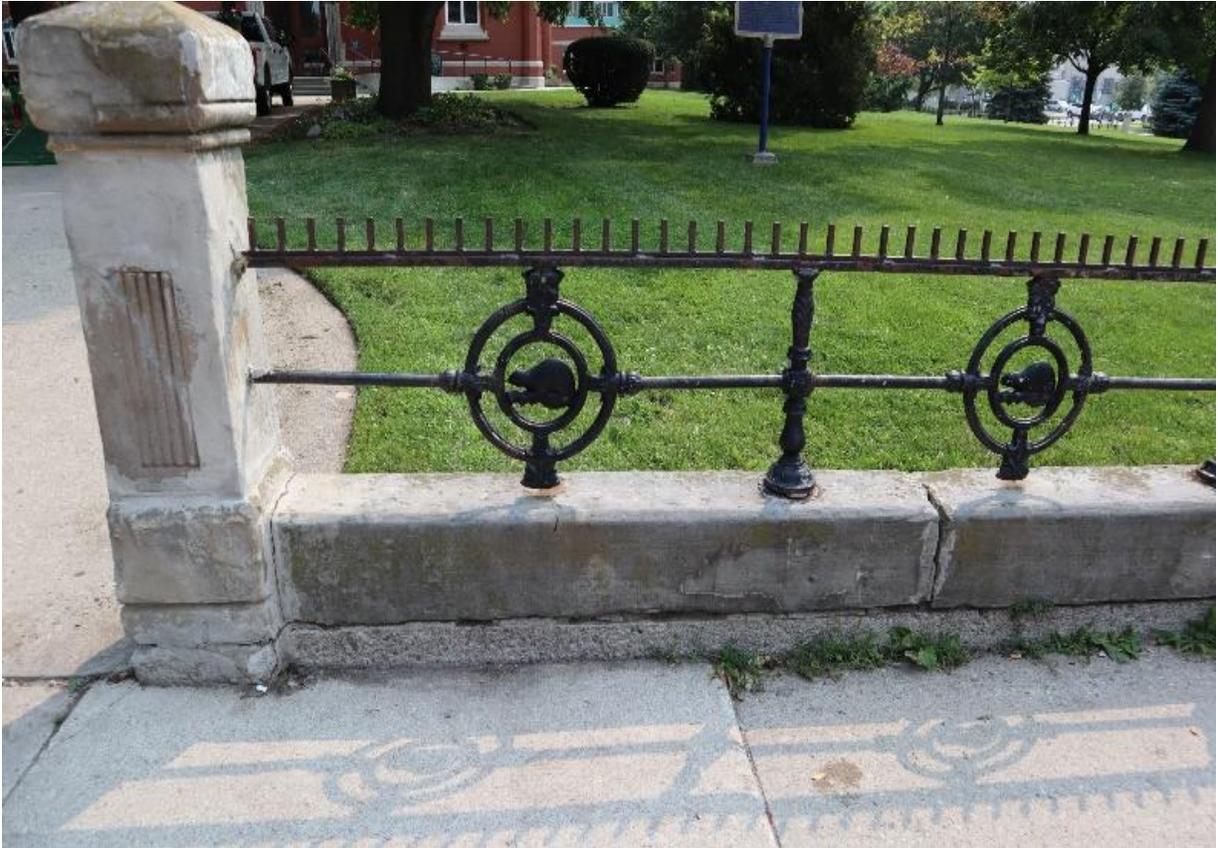
Photograph 39: Section of fence on Richmond Street with a modified top horizontal bar (AECOM, May 2021)

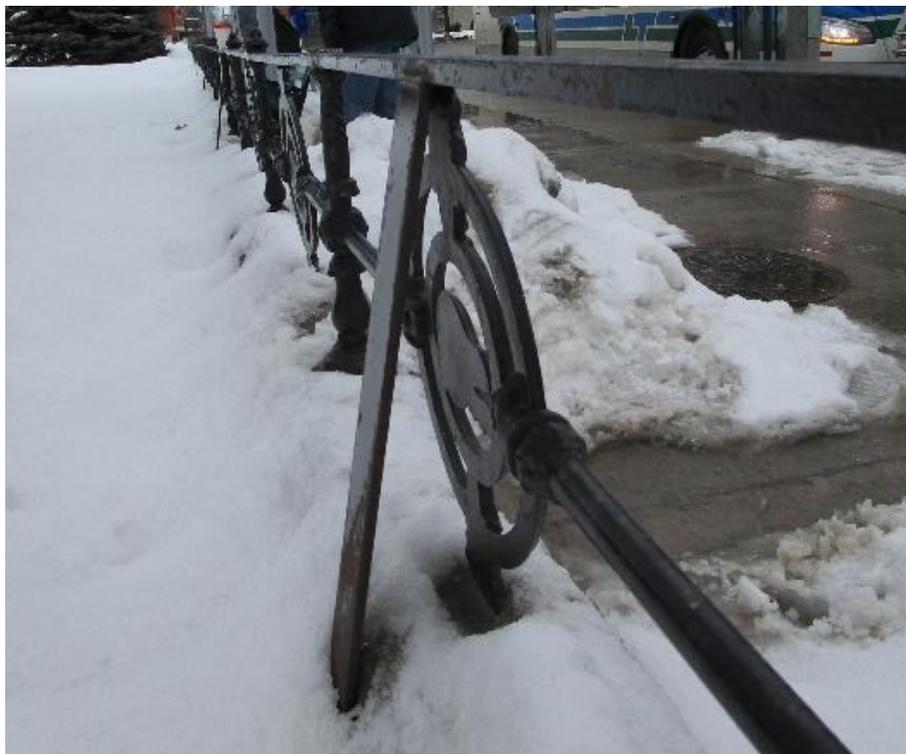
Photograph 40: Example of the back-support brace (AECOM, February 2021)
