## Report to Community Advisory Committee on Planning

**To:** Chair and Members  
Community Advisory Committee on Planning  
**From:** Jana Kelemen, M.Sc.Arch., MUDS, RPP, MCIP  
Manager, Urban Design and Heritage  
**Subject:** Heritage Alteration Permit application by J. Barker for 123  
Wilson Avenue, Blackfriars/Petersville Heritage Conservation  
District  
**Date:** November 9, 2022

### **1.5 Heritage Alteration Permit Application (HAP22-067-L)**

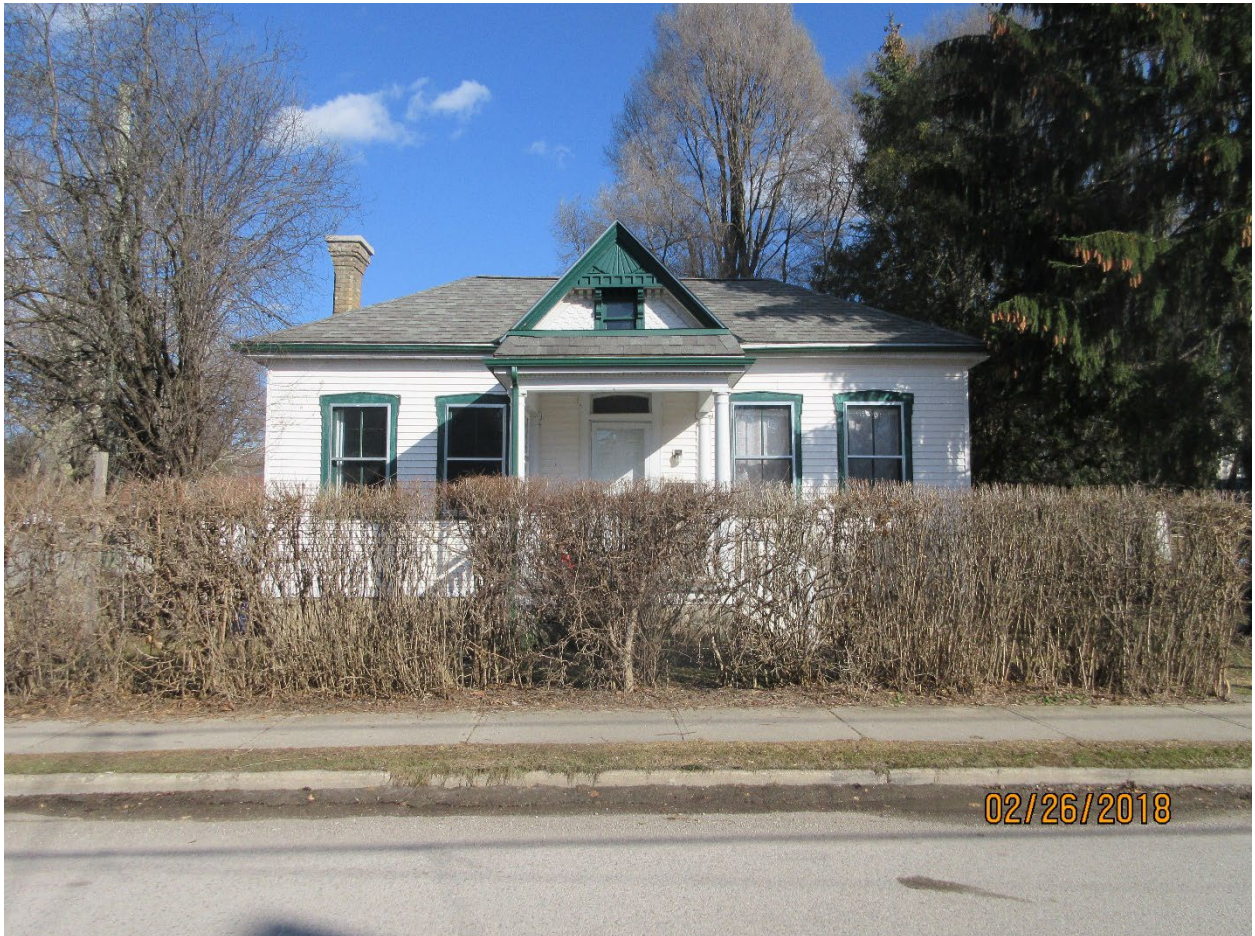
*Image 1: View of the front (west) façade of the Contributing Resource at 123 Wilson Avenue on February 26, 2018.*

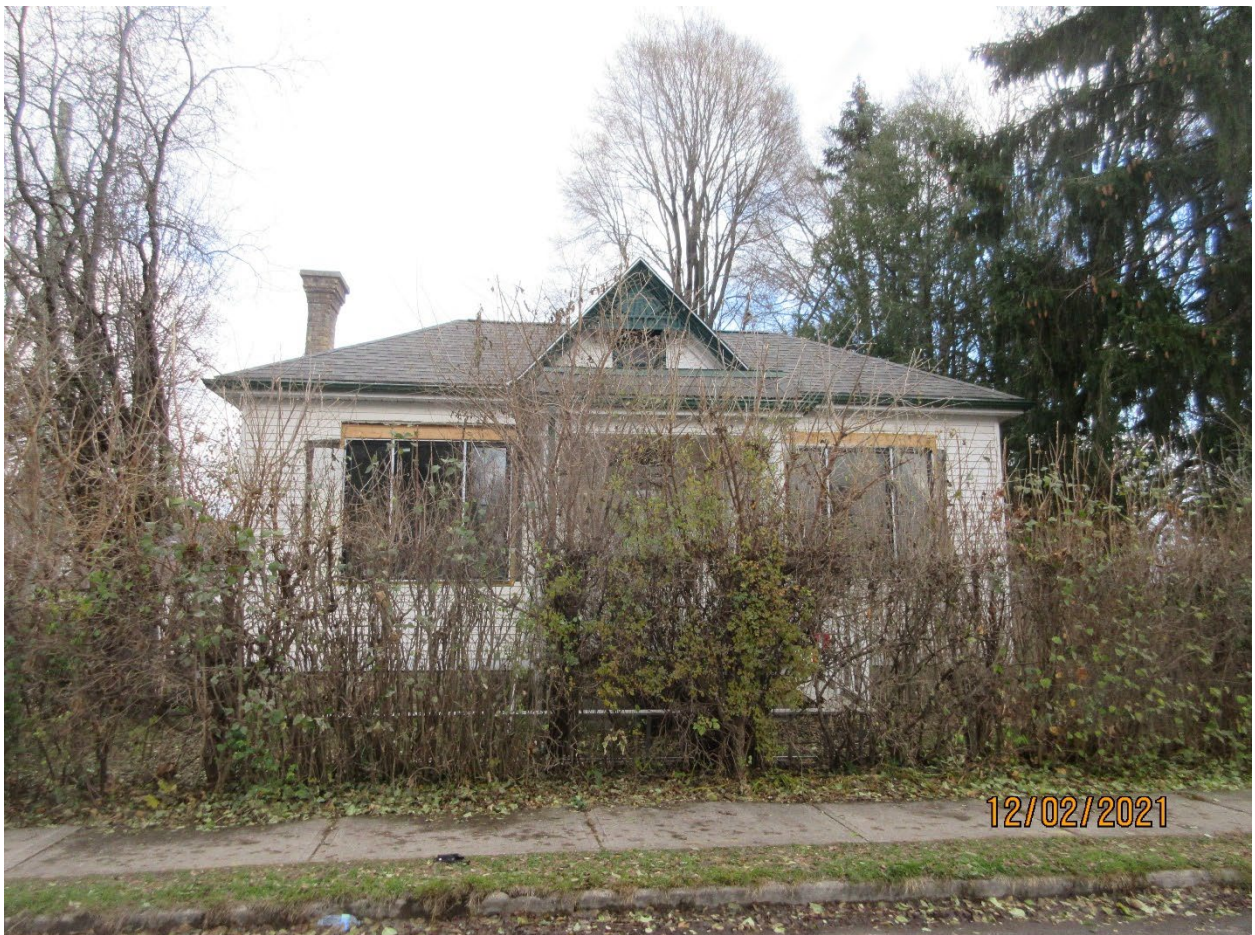
*Image 2: View through the overgrown hedge at 123 Wilson Avenue, showing the alterations to the window openings on west façade.*

Alterations that were completed to the Contributing Resource at 123 Wilson Avenue were not respectful of its heritage attributes and contrary to the goals of the designation of the Blackfriars/Petersville area as a Heritage Conservation District. The alterations eliminated the important five-bay design of the main (west) façade and introduced a large tripartite picture window that is not appropriate for this Contributing Resource.

Unfortunately, none of the original material was retained by the property owner. Structural alterations completed to the window openings, to accommodate the large tripartite windows, have complicated the ability to restore the former windows.

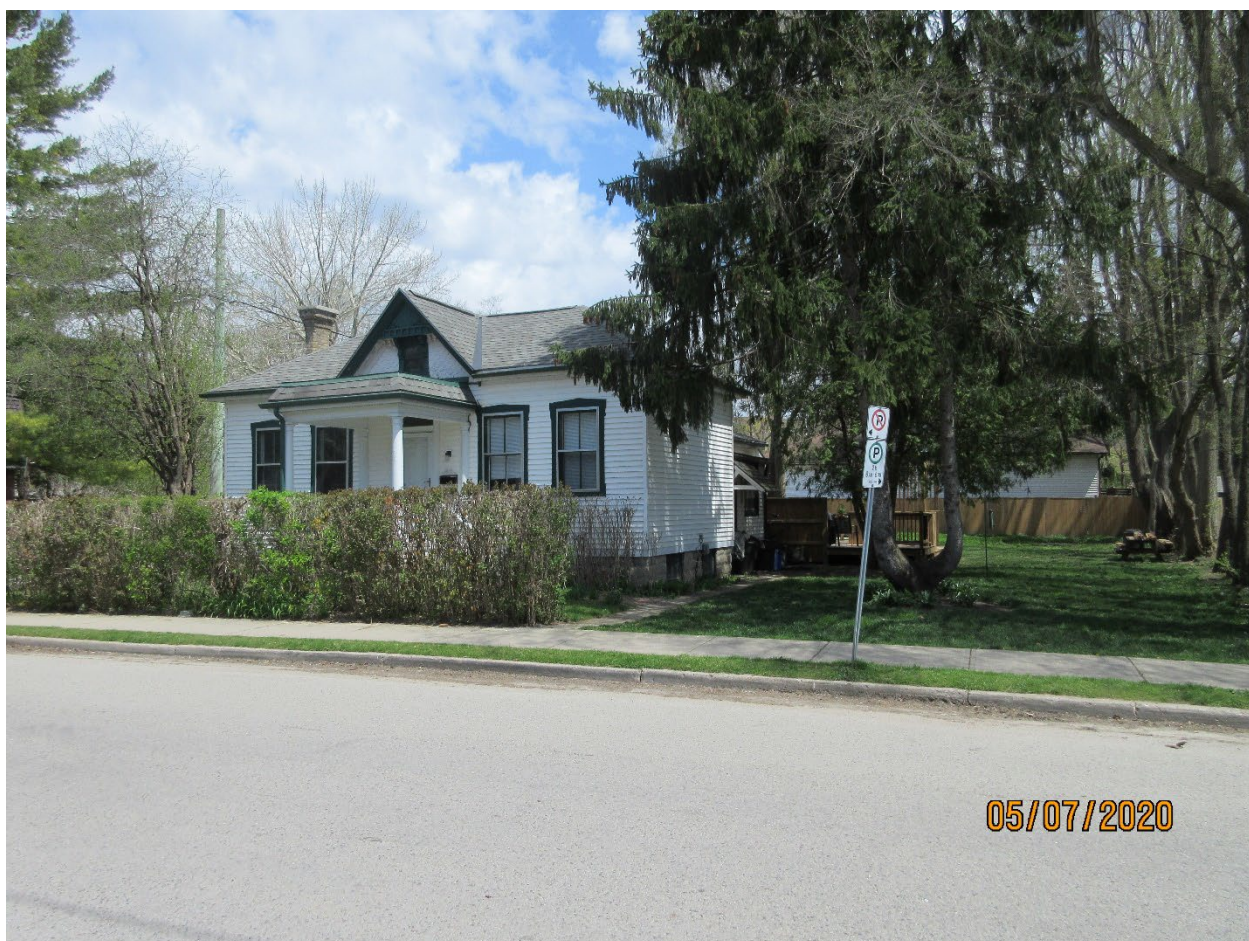
*Image 3: View of the main (west) and south façades of the Contributing Resource at 123 Wilson Avenue on May 5, 2020.*

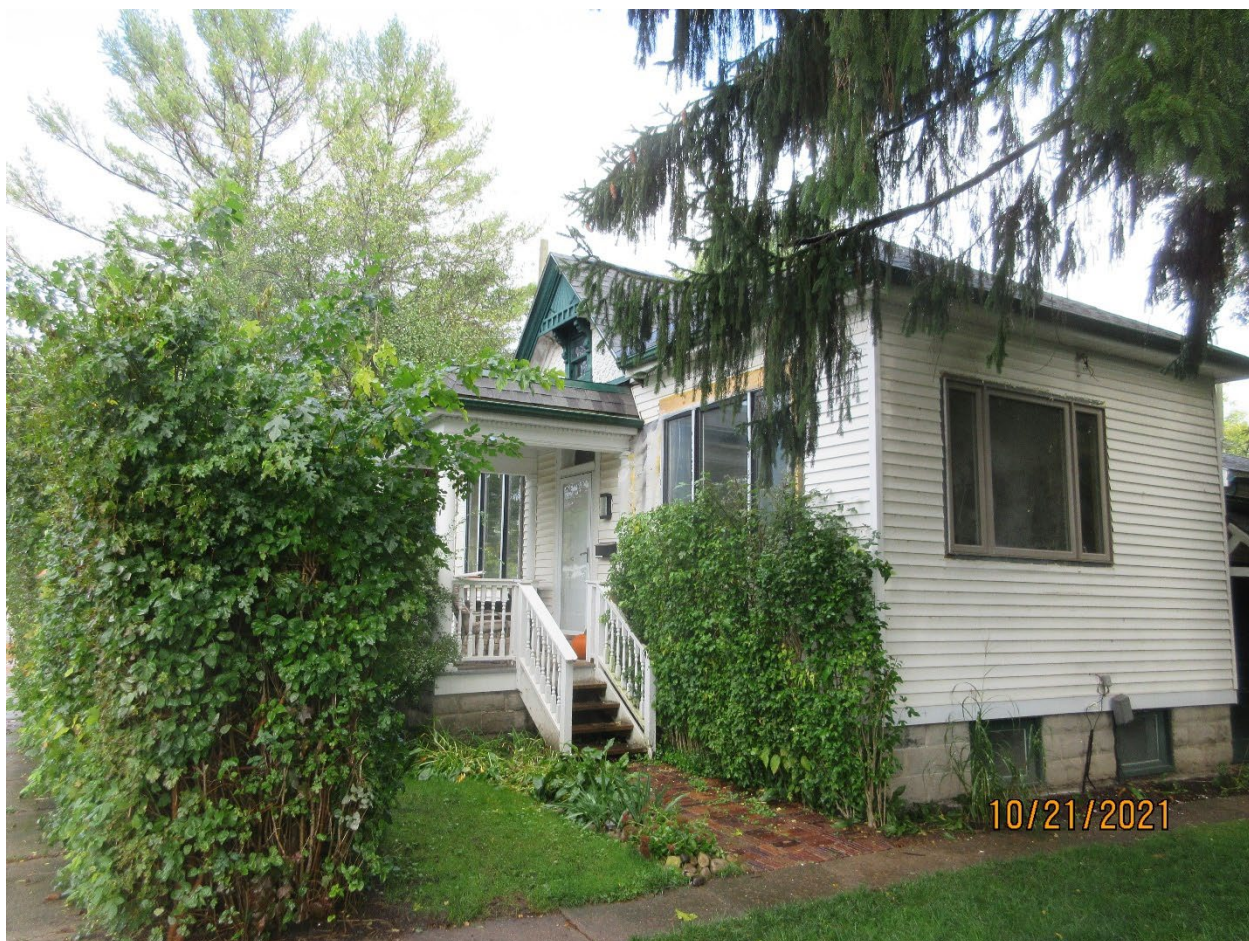
*Image 4: View showing the south half of the main façade and south façade of the Contributing Resource on October 21, 2021.*

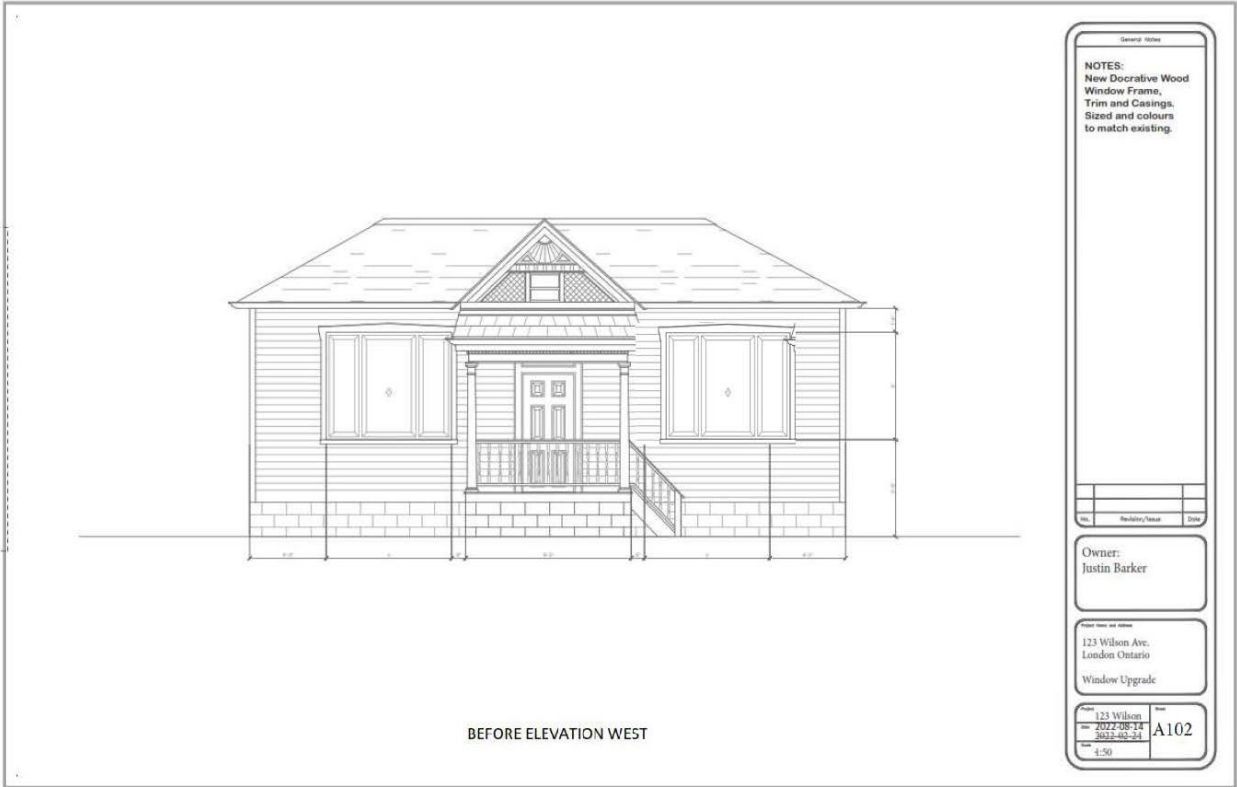
Figure 2: West elevation drawing, submitted as part of the Heritage Alteration Permit application, showing the existing condition.

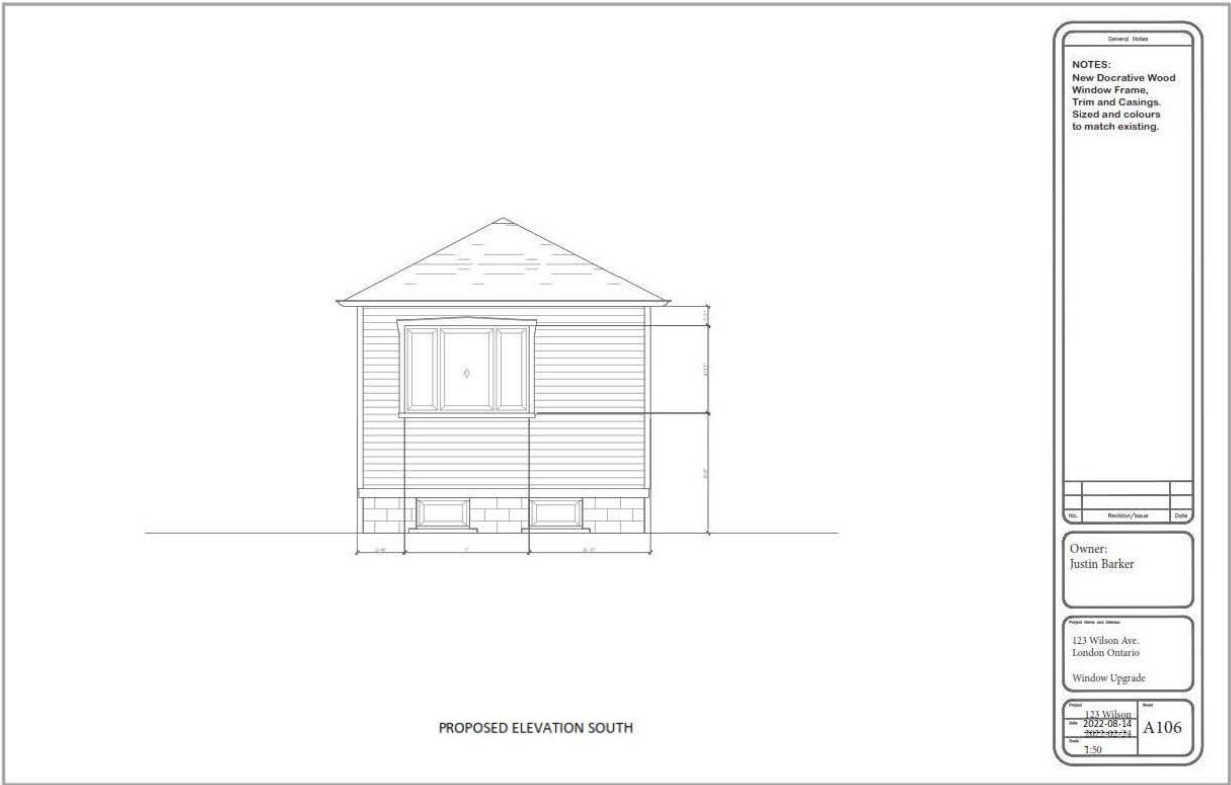
Figure 6: Proposed south façade drawing, submitted as part of the Heritage Alteration Permit application. Showing the proposed trim around the existing window.

Provided that trim, matching/replicating the remaining trim of the house, is installed around the new window on the south façade, no significant adverse impacts are anticipated.
