Report to Community Advisory Committee on Planning

Subject: Heritage Alteration Permit application by O. Cosme for 19

Blackfriars Street, Blackfriars/Petersville Heritage

Conservation District, HAP23-011-L, Ward 13

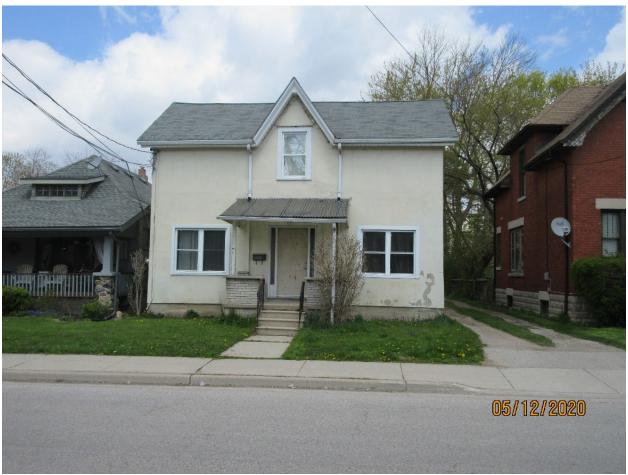
Image 1: Photograph of the subject property at 19 Blackfriars Street, within the Blackfriars/Petersville Heritage Conservation District prior to the installation of the new vinyl siding (2020).

A one-and-a-half storey vernacular residential-type structure is located on the property at 19 Blackfriars Street. The building reasonably matches the setback of adjacent properties along the north side of Blackfriars Street. The building was constructed circa 1885; however, it may date earlier, and follows the Ontario Farmhouse type: one-and-a-half storey, central doorway with windows to each side, end-gable roof, and a Gothic Revival peak in the attic storey above the central doorway. The dwelling is of wood frame construction and had been parged in a rough cast (stucco) exterior cladding.

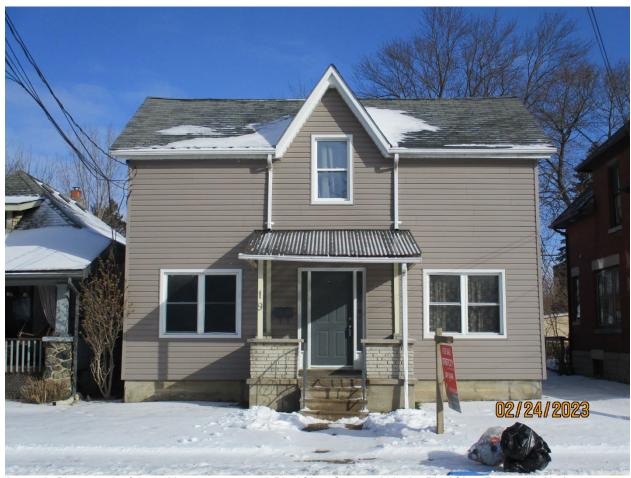
Image 2: Photograph of the subject property at 19 Blackfriars Street, within the Blackfriars/Petersville Heritage Conservation District after the dwelling had been re-clad with vinyl siding (2023).

In January 2023, the City was contacted by the owner of the property located at 19 Blackfriars Street within the Blackfriars/Petersville Heritage Conservation District (HCD). The owner noted that they had recently learned that the property was located within the HCD and advised that they had recently covered the exterior stucco cladding with new vinyl siding. The exterior vinyl siding consists of "Gentek 4.5" Dutchlap" siding.

The Heritage Alteration Permit application noted that the exterior siding was installed through the use of strapping, an installation technique which see furring strips applied to the existing exterior in order to provide a stable surface or backing for the new exterior cladding to be installed upon. Typically, the installation of strapping requires that the furring strips be affixed to the existing exterior.

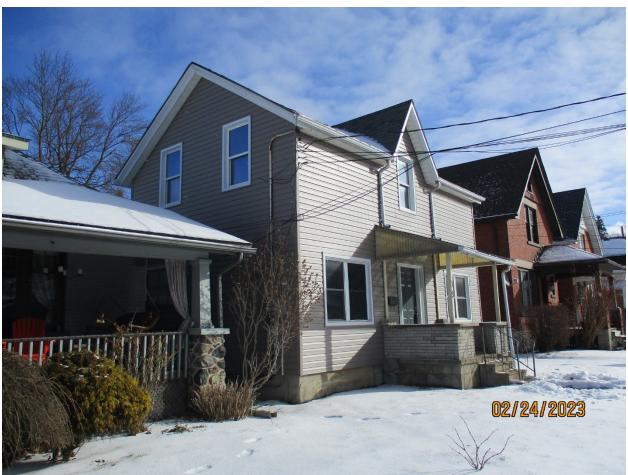
Image 3: Photograph of the subject property at 19 Blackfriars Street, within the Blackfriars/Petersville Heritage Conservation District after the dwelling had been re-clad with vinyl siding (2023).

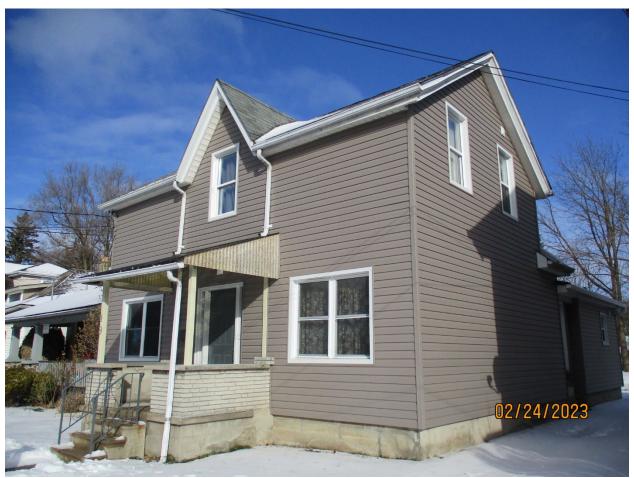
Image 4: Photograph of the subject property at 19 Blackfriars Street, within the Blackfriars/Petersville Heritage Conservation District after the dwelling had been re-clad with vinyl siding (2023).
