<b>TO:</b>	<b>CHAIR AND MEMBERS CIVIC WORKS COMMITTEE MEETING ON SEPTEMBER 9, 2013</b>
<b>FROM:</b>	<b>JOHN BRAAM, P. ENG. MANAGING DIRECTOR, ENVIRONMENTAL AND ENGINEERING SERVICES &amp; CITY ENGINEER</b>
<b>SUBJECT:</b>	<b>BLACKFRIARS BRIDGE – STRUCTURAL REPAIRS AND TEMPORARY CLOSURE</b>

*Preliminary Inspection Findings*

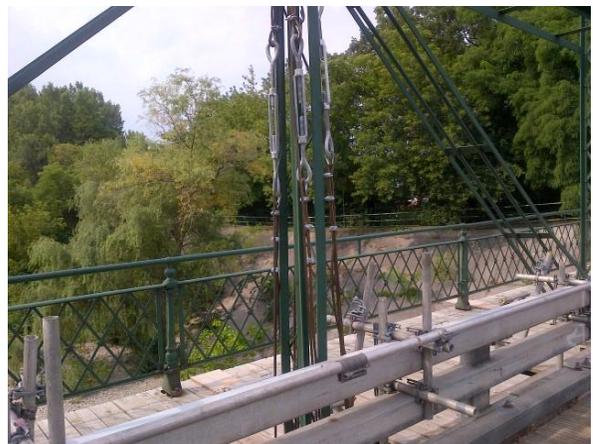
- To address the structural deficiencies and provide a lifespan of 2-3 years, the top chord would be strengthened using external bracing (~200 locations), a temporary wire hanger system would be installed at the 10 locations, broken diagonals would be repaired.
- Wooden deck would be replaced.
- 18 week closure (until December 2013)
- Additional Cost: \$430,000 including engineering and contractor costs.
