<b>TO:</b>	<b>CHAIR AND MEMBERS LONDON ADVISORY COMMITTEE ON HERITAGE</b>
<b>FROM:</b>	<b>JOHN M. FLEMING MANAGING DIRECTOR, PLANNING AND CITY PLANNER</b>
<b>SUBJECT:</b>	<b>REQUEST FOR DEMOLITION SOUTHSIDE CONSTRUCTION MANAGEMENT LTD. 175/179/181 KING STREET WEDNESDAY, JUNE 8, 2016</b>

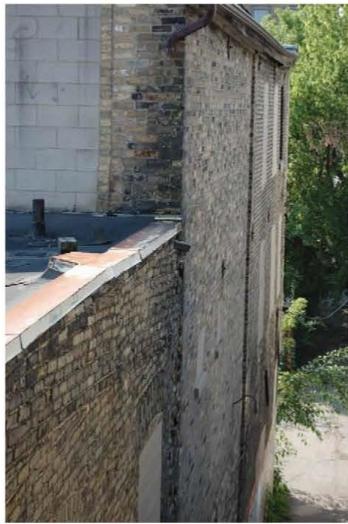
*Photograph 3:* West wall showing the main building (Two storey), the middle section (three storey) and the rear addition (three storey).

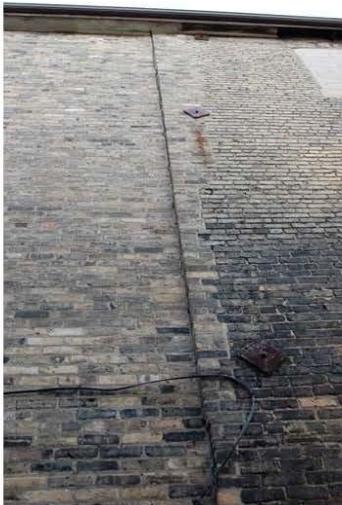
*Photograph 17:* Joint between the middle and rear (south) addition.

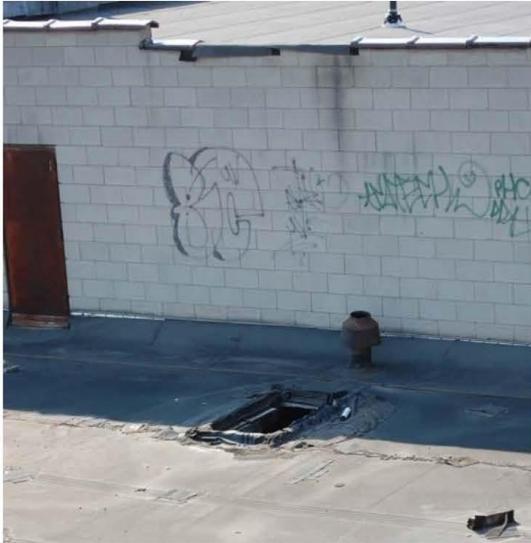
*Photograph 20:* Open roof hatch in the second storey of the original building.

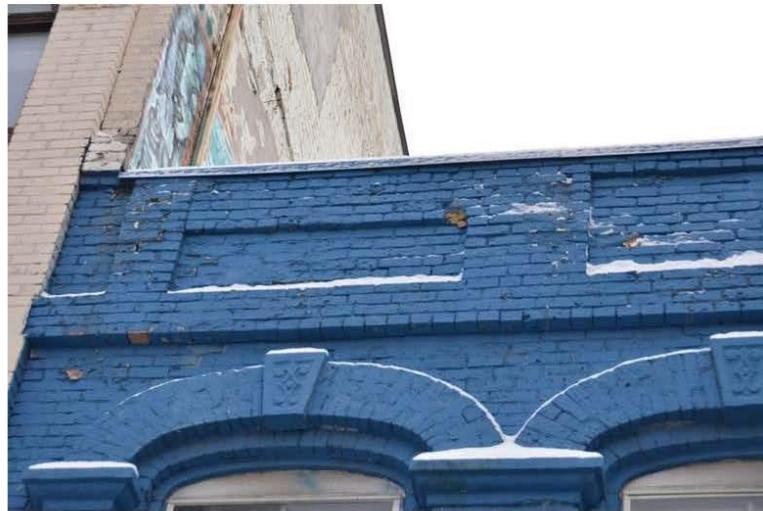
See attached **Photo No. 02**. This photo shows some of the bricks in the parapet have delaminated. The pieces of delaminated brick are prevented from falling from the adhesion of the painted wall. The concern is that these pieces of brick and mortar will fall and injure a pedestrian.

Photo No. 02: Delaminating Masonry Parapet

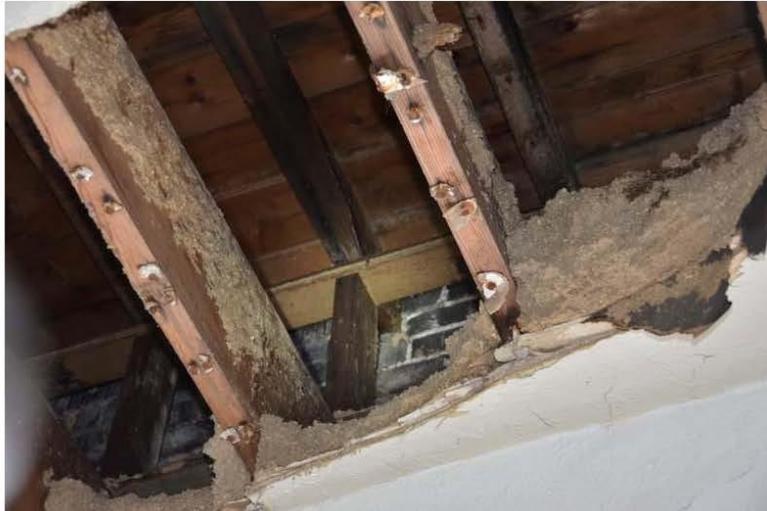
See attached **Photo No. 03**. The ceiling joists, below the roof, appear to be framing into the masonry wall. The sloped roof joists however, appear to stop short of the inside face of the parapet. We have a few concerns regarding the construction of the front wall/parapet as constructed and the condition of the parapet, they are as follows:

Photo No. 03: Ceiling/Roof Joists at North Parapet

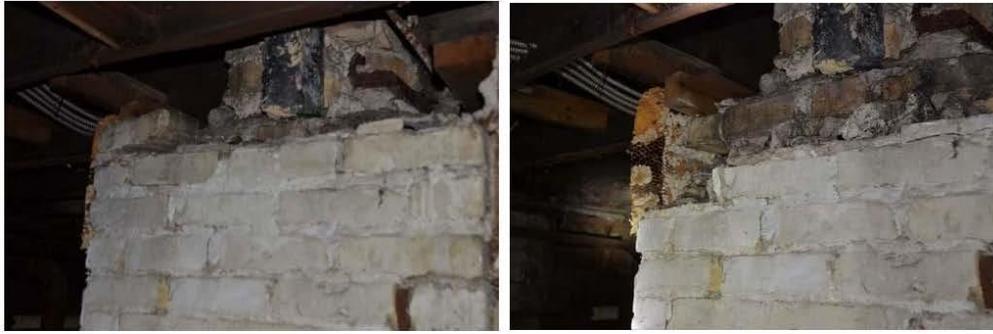
See attached **Photos No. 05 and 06**. The two photos capture the top of the same masonry pier in the basement of the building. The comparison of the photos shows the difference in the top of the pier before and after some of the bricks were removed by hand. There were many piers throughout the building where the masonry was loose and could be taken out with little effort. Visible at the top right corners of each of photos **05 & 06**, is the exposed base plate of the main floor steel columns. These base plates are exhibiting severe corrosion. Combined, these matters raise serious concern as to the entire structural integrity of the piers located in the basement.

Photo No. 05 & 06: Crumbling Masonry Pier

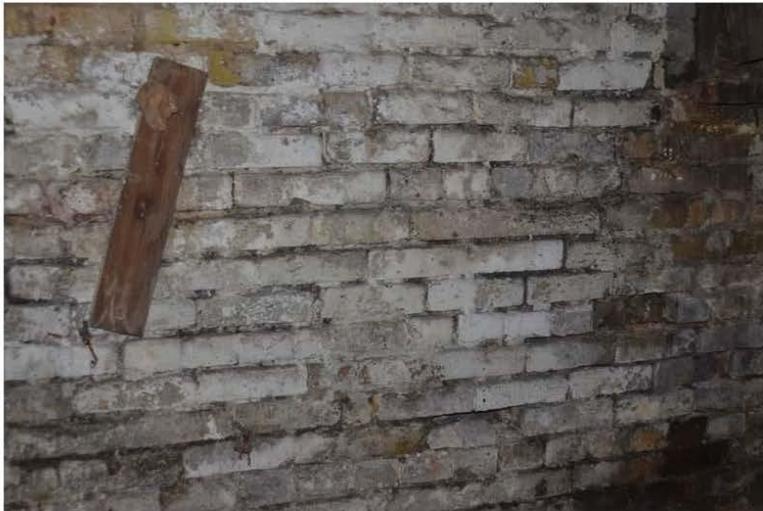
See attached **Photo No. 07**. The photo is taken in the basement of the building. Nearly every wall observed showed signs of severe mortar loss in the joints. The loss of mortar severely reduces the capacity of the wall since its original state. The lengths of exterior basement walls that are backfilled with soil should be shored as the lateral loads from the fill could potentially collapse the walls.

Photo No. 07: Basement Wall with Severe loss of Mortar

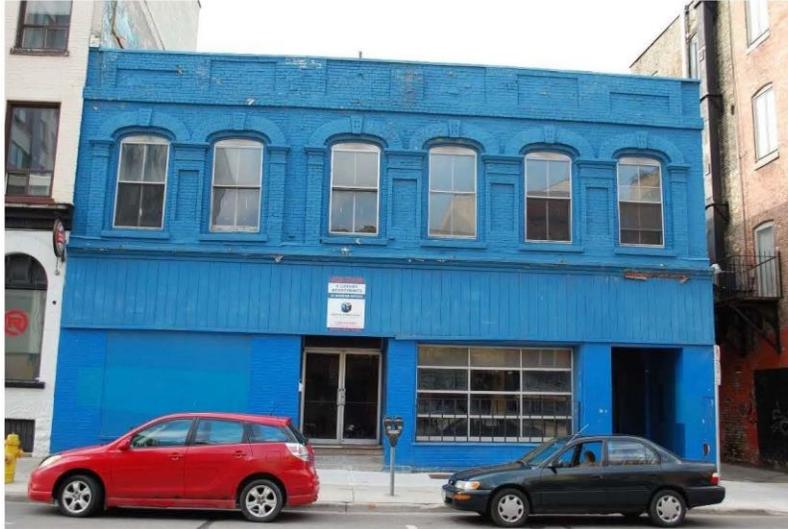
The building fronts on King Street (Photograph 1) and is two storeys in height at the front (north elevation) and three storeys at the rear (Photograph 2). The building has three distinct sections characterized by differences in the brick type and placement pattern (Photographs 3 and 4). This difference in construction indicates that the original building had two additions onto the original two-storey building.

*Photograph 1:* North elevation fronting on King Street.

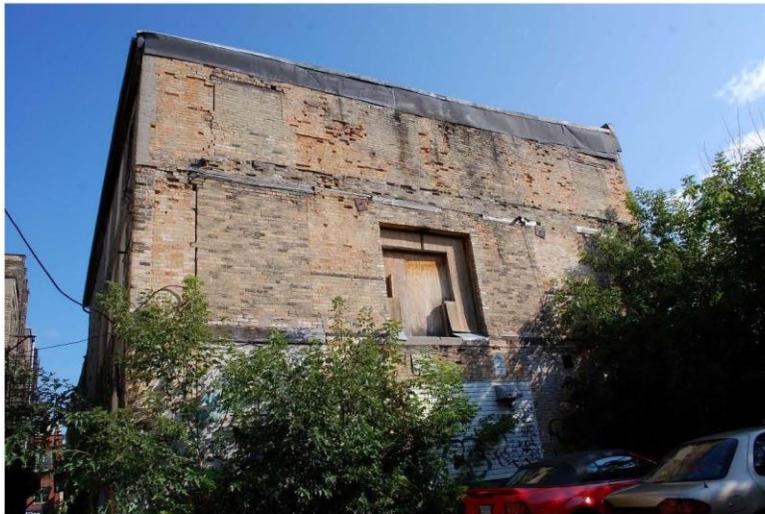
*Photograph 2:* South Elevation; three storeys in height.

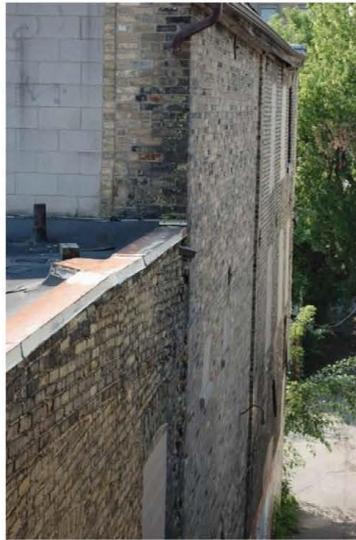
*Photograph 3:* West wall showing the main building (Two storey), the middle section (three storey) and the rear addition (three storey).

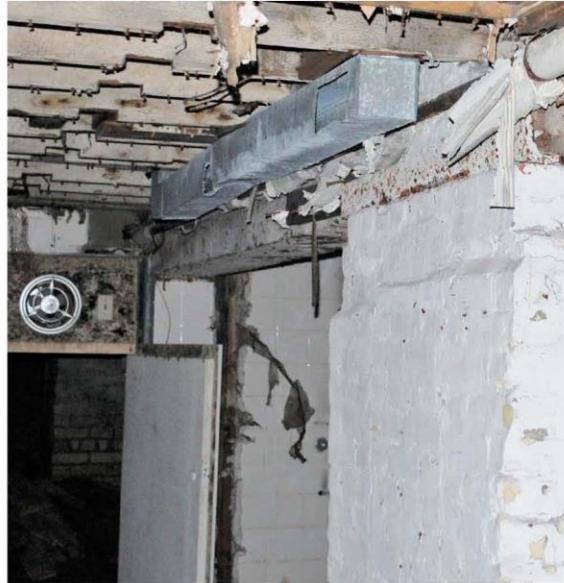
The rear portion of the partial basement was also a low height area (Photograph 12), but with limited access from the partial basement. The floor height in this area varied and was not easily accessible, therefore our observations were made from the partial basement area.

*Photograph 12:* Access door (lower left) to south crawlspace with pier beyond.

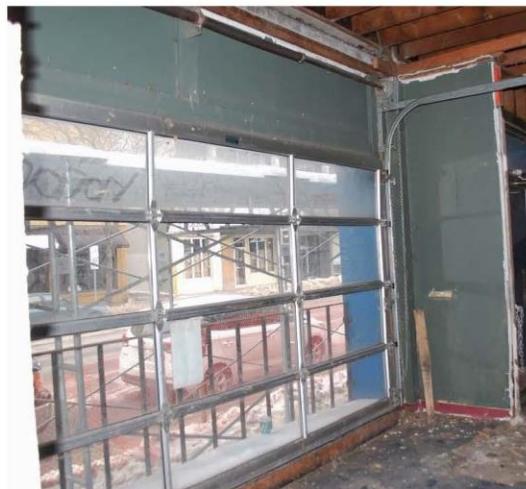
*Photograph 13:* 'Garage Door' windows in the north building face fronting on King Street.

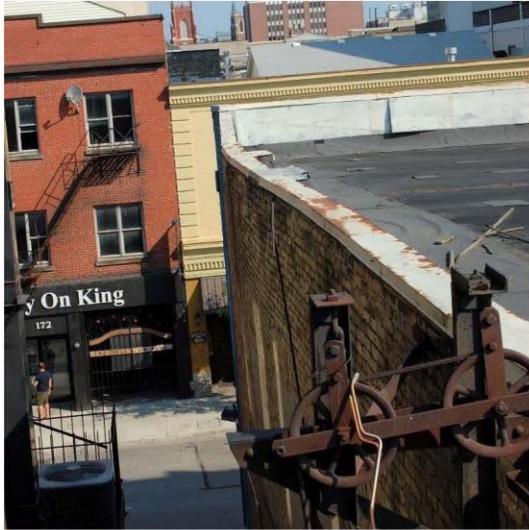
*Photograph 20:* Outward movement of the parapet on the west elevation.

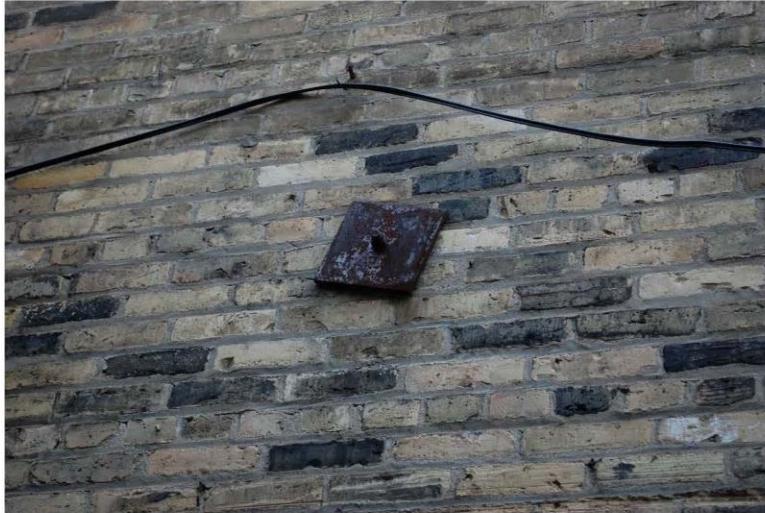
*Photograph 24:* Tie-back plates on the exterior of the middle addition to connect the floor and wall system.

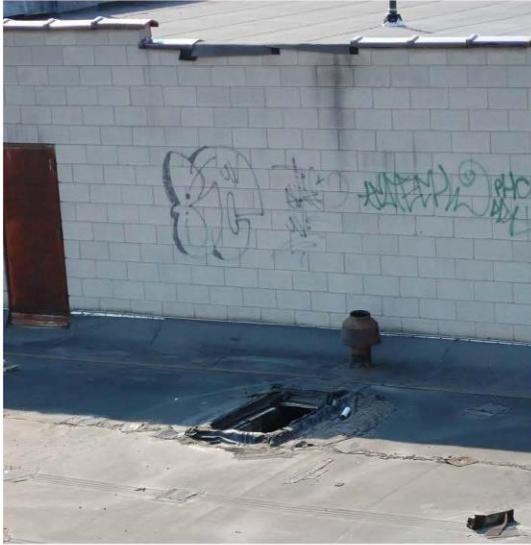
*Photograph 27:* Open roof hatch in the second storey of the original building.

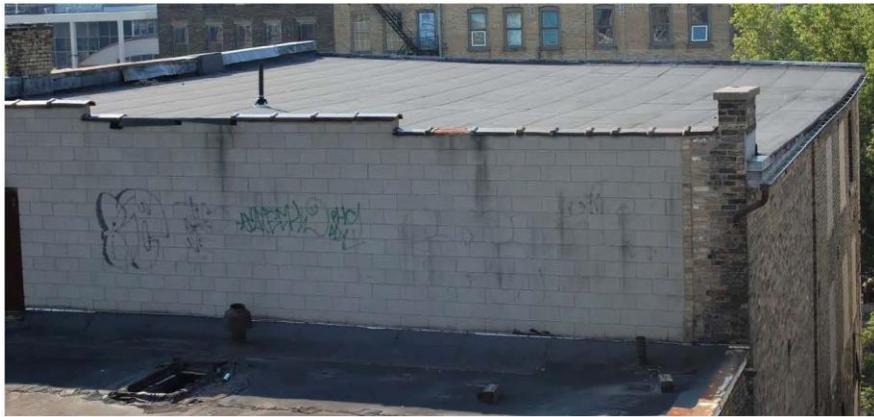
*Photograph 33:* North wall of south addition. Hollow concrete block capped with clay tile capping.

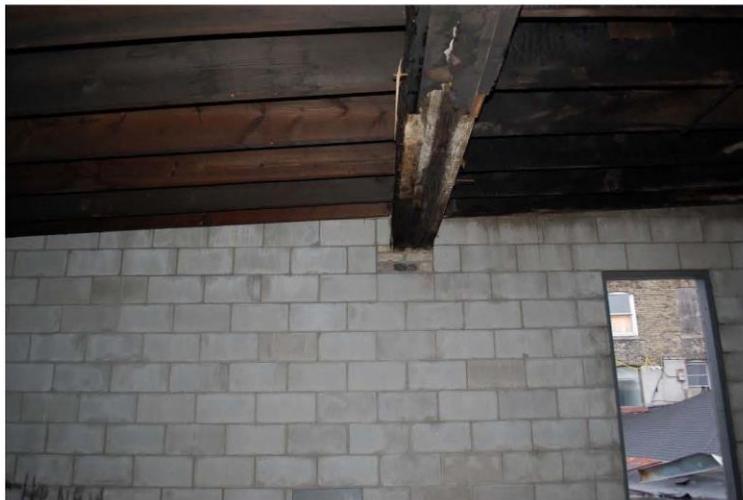
*Photograph 34:* North wall of south addition from the interior.

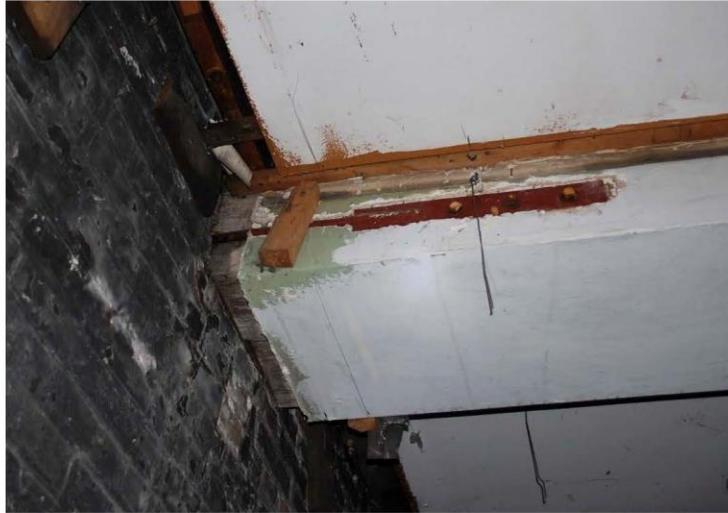
*Photograph 41:* Rod assembly with exterior wall plate to restrain the masonry wall.

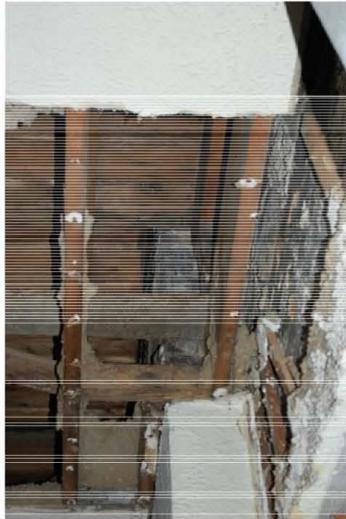
*Photograph 44:* Approximately 1" +/- movement of sheathing away from wall. No positive connection between roof framing and masonry.

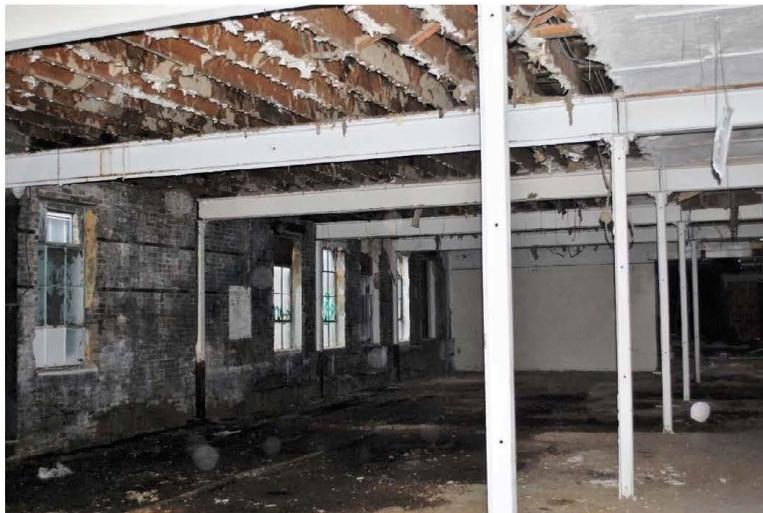
*Photograph 45:* Timber joist and steel framing supported the roof.

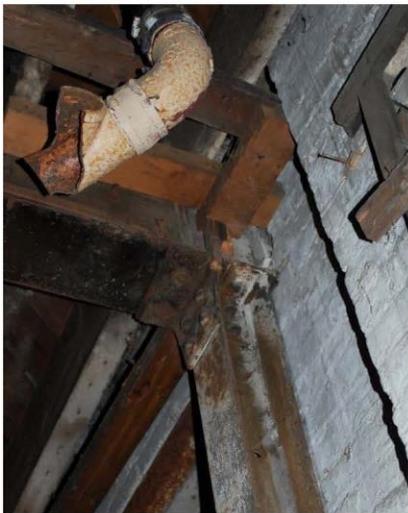
*Photograph 46:* Potential friction connection between the steel and the brick wall.
